# **Risk control for small pressure vessels: café boilers, bench-top autoclaves, and model steam engines**

Prepared by researchers at the  
**Health and Safety Executive**

**RR1177 (2022)**  
**Research Report**

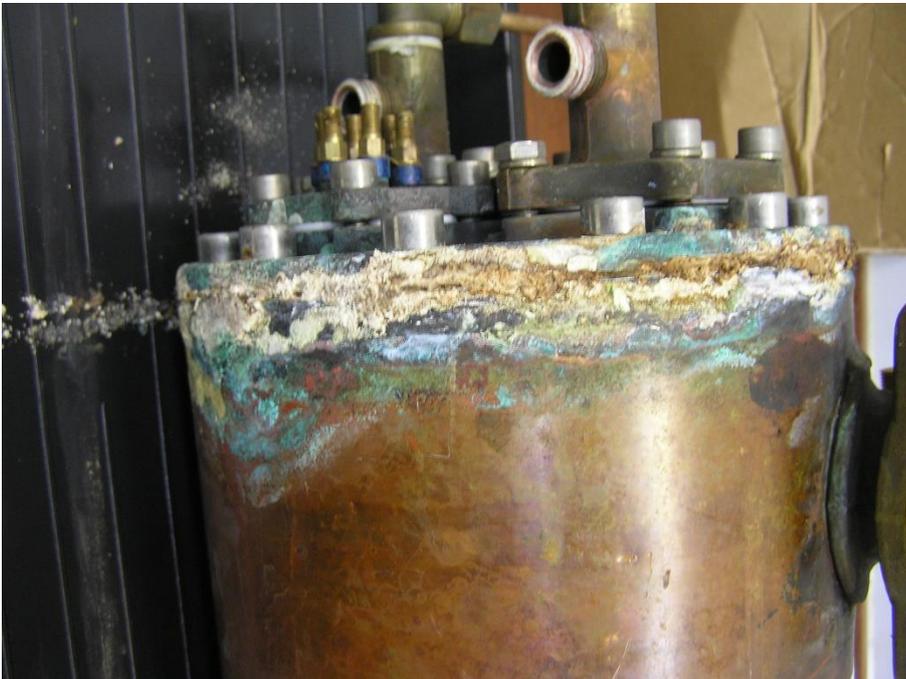
Sample 14034 was nominally 610 mm in length and 220 mm external diameter. Service conditions had resulted in this boiler undergoing considerable external tarnishing, with a significant build-up of white and green coloured corrosion deposits at the seals associated with both end plates, Figure 5.

**Figure 5** Corrosion deposits at end plate *(Image No. P2202727.jpg)*

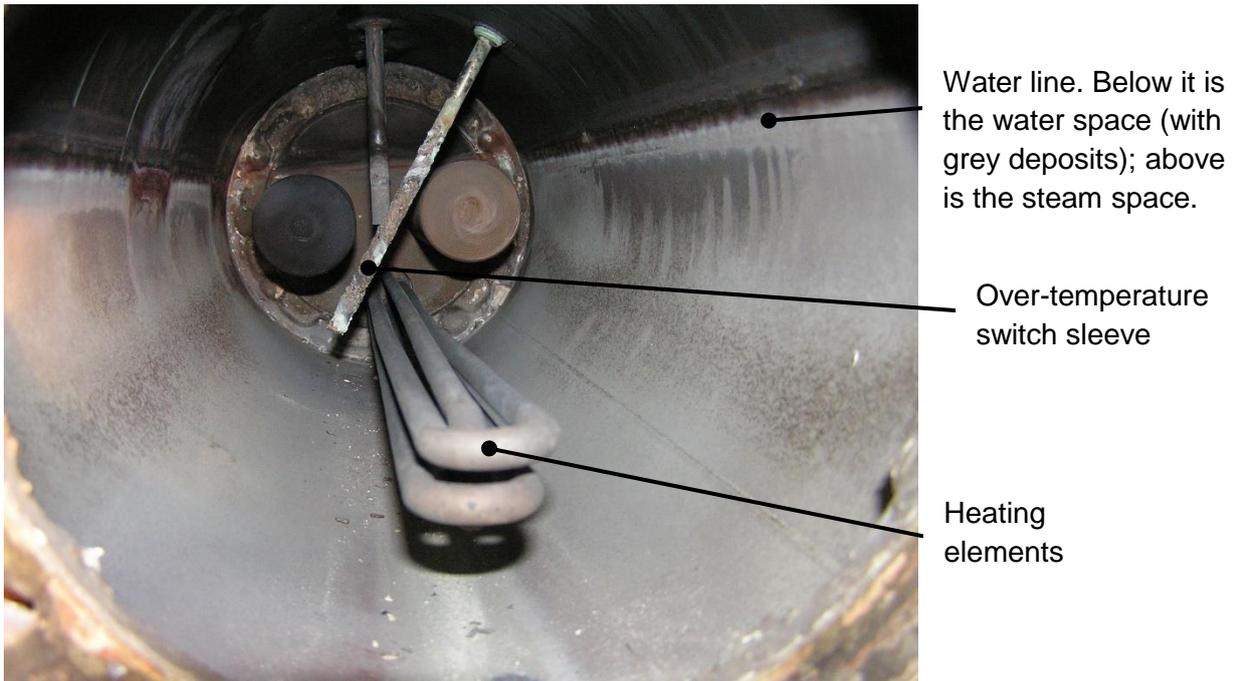
Internally and below the water level (BWL) there were deposits of loose, flaky, black, and white debris, Figure 6. In the above water level location (AWL) the internal cylinder walls were lightly coated in a very adherent black deposit.

**Figure 6 Grey deposits in interior of vessel** (Image No. P2202740.jpg)

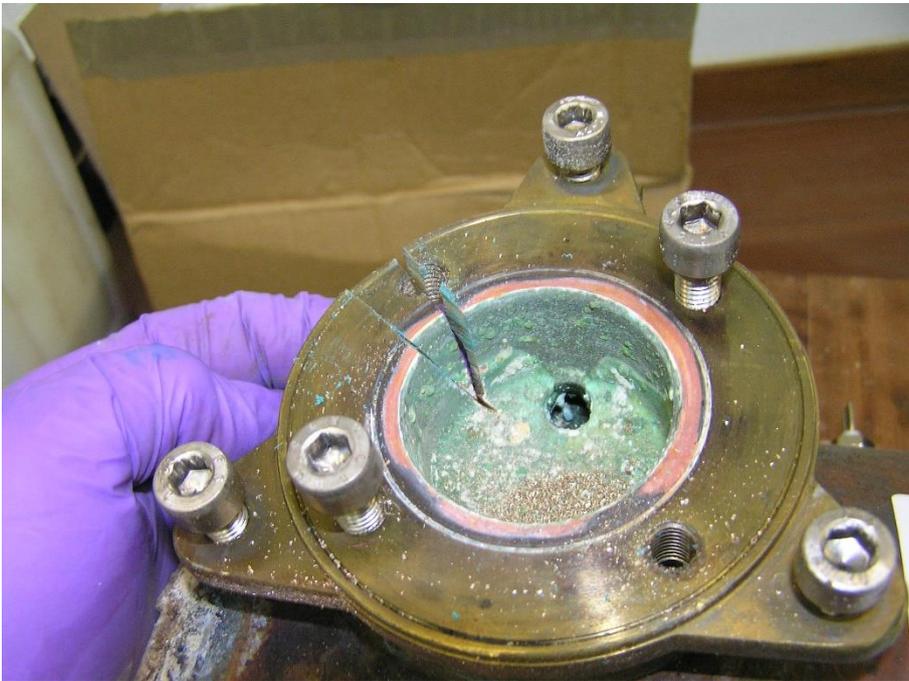
- a. a weld between the end plate flange and vessel wall, Figure 7;
- b. the underside of the boiler;
- c. a transverse section through a fitting attached to the heat exchanger; and
- d. a section through one of the brew heads, the interior of which was thickly encrusted with green corrosion deposit, Figure 8.

**Figure 8** Section taken through a group (brew) head (*Image No. P1010832.jpg*)

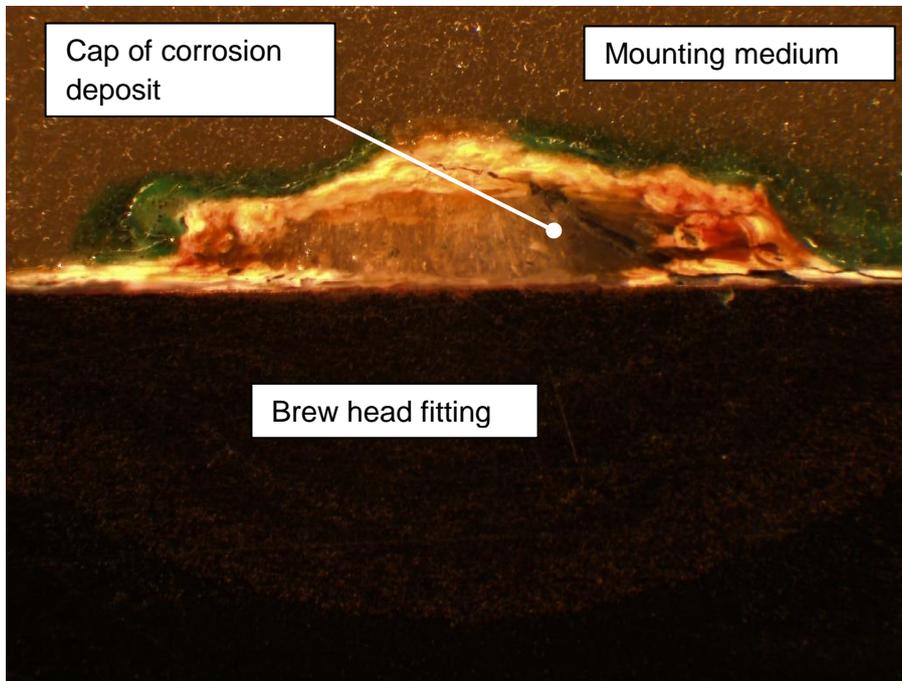
was found to have affected all the samples examined, it had not penetrated into the cross-sections to any great extent, and as such its influence was cosmetic and did not compromise the structural integrity of the boiler.

**Figure 8a Section through the brew-head showing corrosion deposit sitting above the surface of the fitting** (Image No. 14260-02x20.jpg)

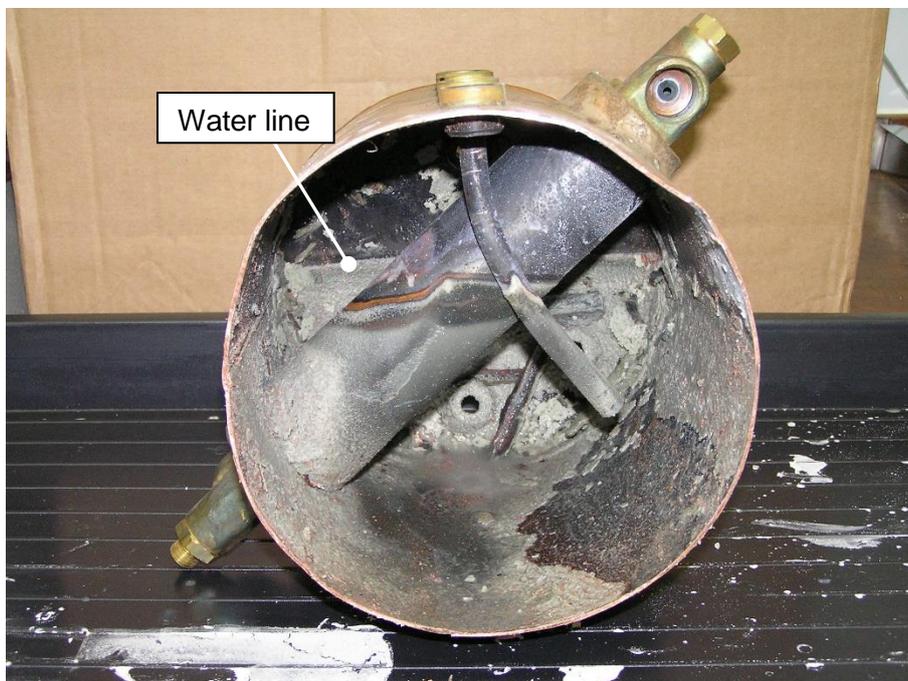
Cutting open the boiler revealed the accumulated thick plate-like lime-scale deposits in the BWL regions of the vessel, Figure 9. The scale was also observed on fittings such as heating elements, temperature sensors and heat exchangers which lay in the BWL region.

**Figure 9** Interior of vessel showing lime-scale deposits (Image No. P1010867.jpg)

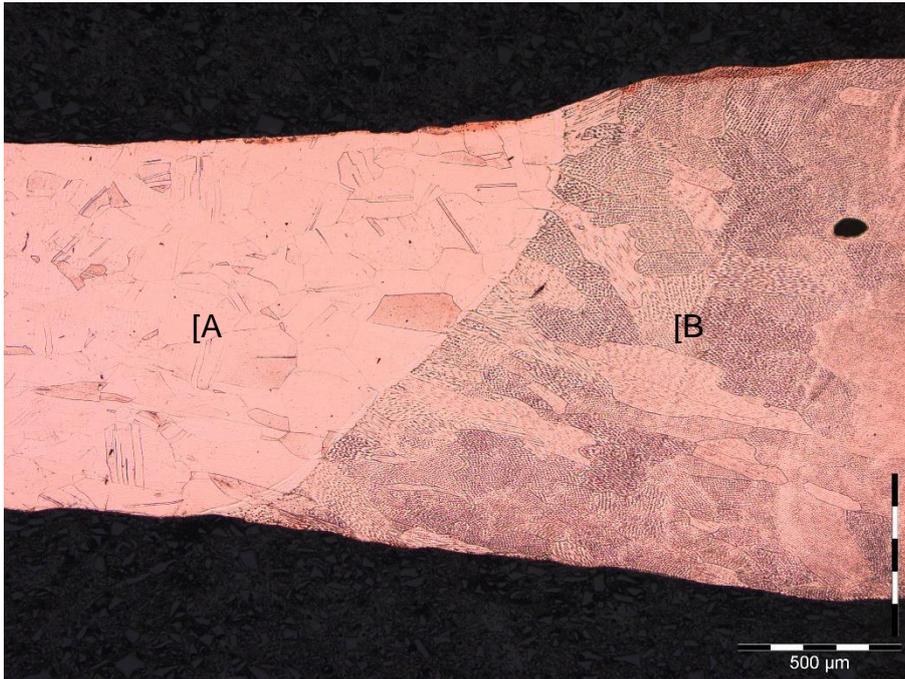
In the heat affected zone (HAZ) either side of the weld, the grain structure had coarsened very significantly, Figure 11. Within the weld metal there were fine, linear, mottled structures indicative of fused copper.

**Figure 11** Showing coarse grains in the HAZ of the parent metal [A], and fine structures in fused weld metal [B]. (Image No. 14134 met-1-2.jpg)

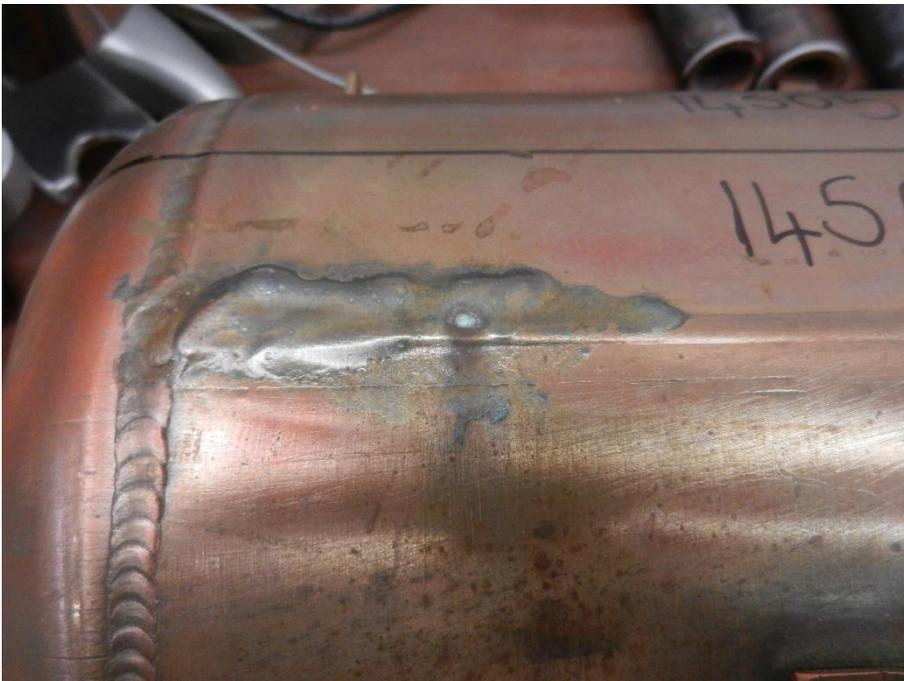
Boiler sample 14471 from manufacturer C was nominally 600 mm in length and 220 mm in diameter. One end of the vessel comprised a domed pressing which had been welded to the vessel wall. The weld at this and at the opposing end, which was comprised of a ring-shaped flange welded to the vessel wall, was generally uniform. A visual examination showed the weld to be free of defects. The ring-shaped flange permitted a flat brass endplate to be bolted onto it. The longitudinal butt weld running the length of the vessel appeared uniform except towards its proximity to the domed end, where the weld became lumpy and misshapen indicative of over welding having been used in this location, Figure12.

**Figure 12 Irregular weld deposit** (Image No. DSCN5984.jpg)

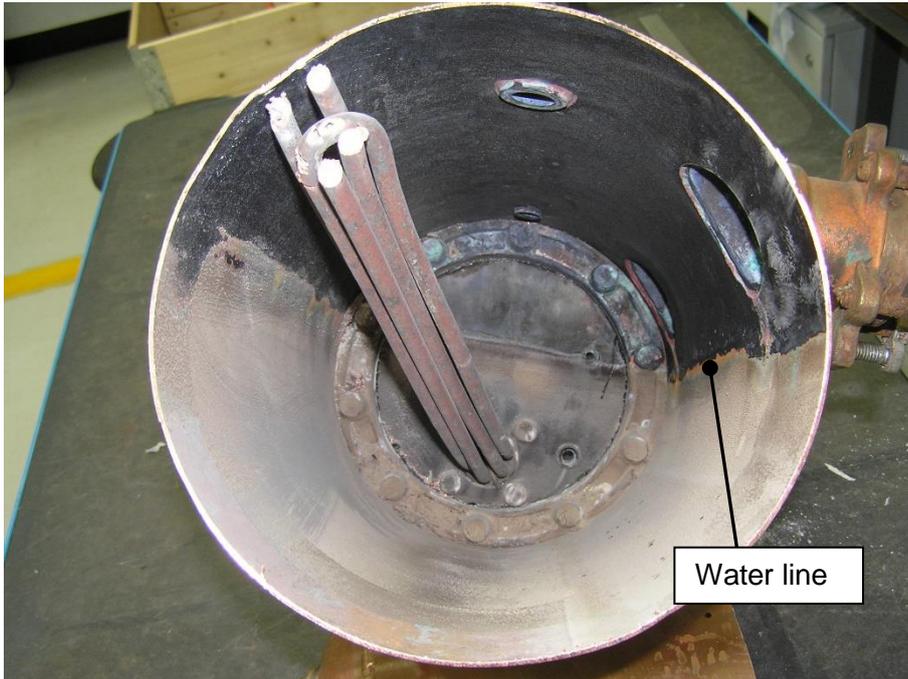
The vessel was in good condition with very light tarnishing. The interior of the vessel in the BWL region was only lightly coated with lime-scale deposits, Figure 13. The longitudinal weld was uniform and intact. Consistent with all the other vessels examined the AWL blackening of the wall was present.

**Figure 13 Interior of boiler vessel** (Image No. P1012987.jpg)

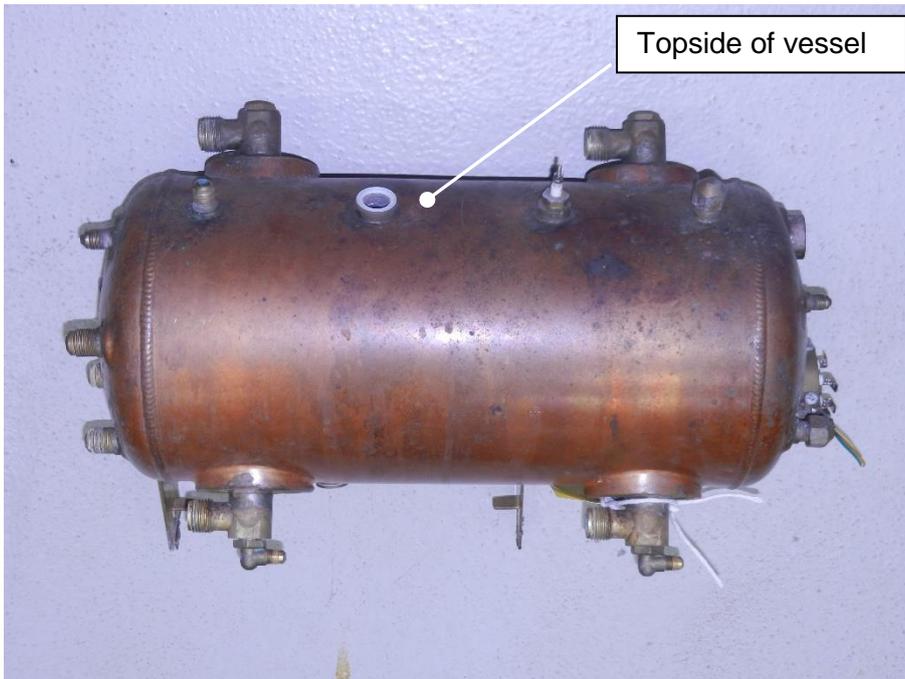
As received, the boiler vessel was tarnished with an accumulation of surface debris and dirt resulting from its service use (particularly on the top external surface), Figure 14. Other than one or two tiny superficial pits, there were few indications of corrosion on the vessel walls although spot staining was more prevalent. A small quantity of light white coloured deposit was observed on a blanked end cap on the left-hand brew head which may have been indicative of minor leaking. The interior of ports, where accessible, had very slight deposits of a white powdery consistency.

**Figure 14 Boiler vessel, manufacturer D.** (Image No. DSCN 5905.jpg)

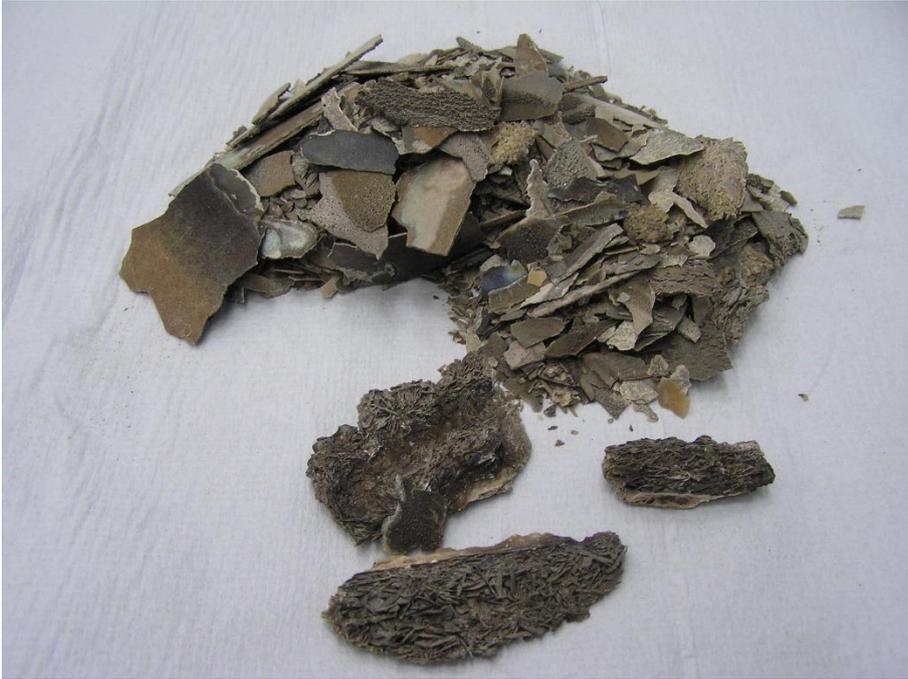
Internally, in the BWL location, the vessel was found to be heavily contaminated with massive accretions of scale, much of which had spalled off when the vessel was cut to reveal the interior. This created a mass of loose, flaky debris in the base of the vessel, Figure 15. In particular, the heating elements had been severely affected with lime-scale – some of these deposits were 15 mm thick amongst the elements. A sample of this deposit was removed for EDS analysis, Figure 16. Using EDS, four spectra were taken across the surface of the deposit; these indicated the following consistent quantities of elements: oxygen 53 %; Calcium 46 %; 1 % of traces of magnesium, phosphorous, sulphur and copper. This confirmed that the residues had been the result of hard water usage. Carbon was also present but could not be reliably quantified owing to the preparation technique used (as discussed in section 2.6.1).

**Figure 15** Lime-scale accumulated in base of vessel (*Image No. P1012978.jpg*)

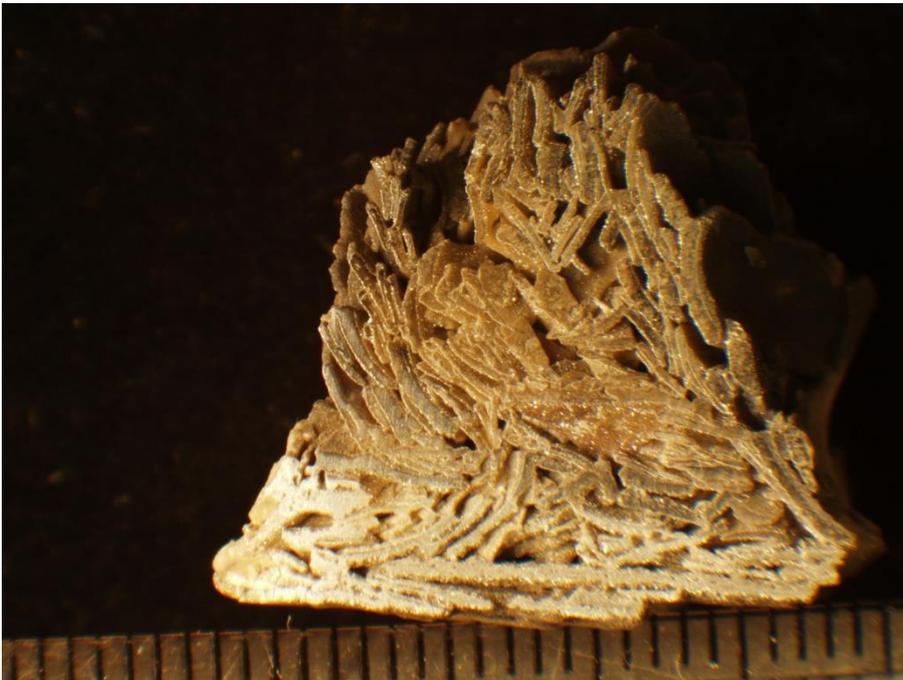
**Figure 16** Solid deposit of lime-scale from vicinity of heating element (divisions on scale are millimetres) (*Image No. 14432 massive scale.jpg*)

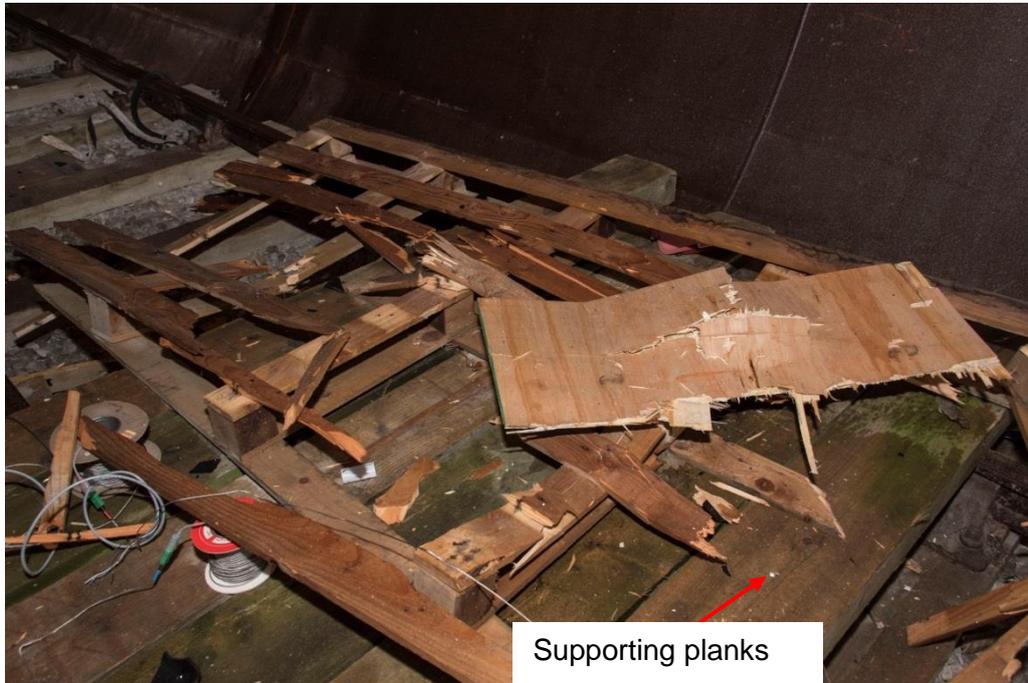
All the panels and pallets that were supporting the café boiler underneath were badly damaged by the pressure release. A typical example is shown in Figure 17.

**Figure 17** Post-test – Condition of the timber panel and pallet supporting the machine (Image No. AIS 1603011\_100)

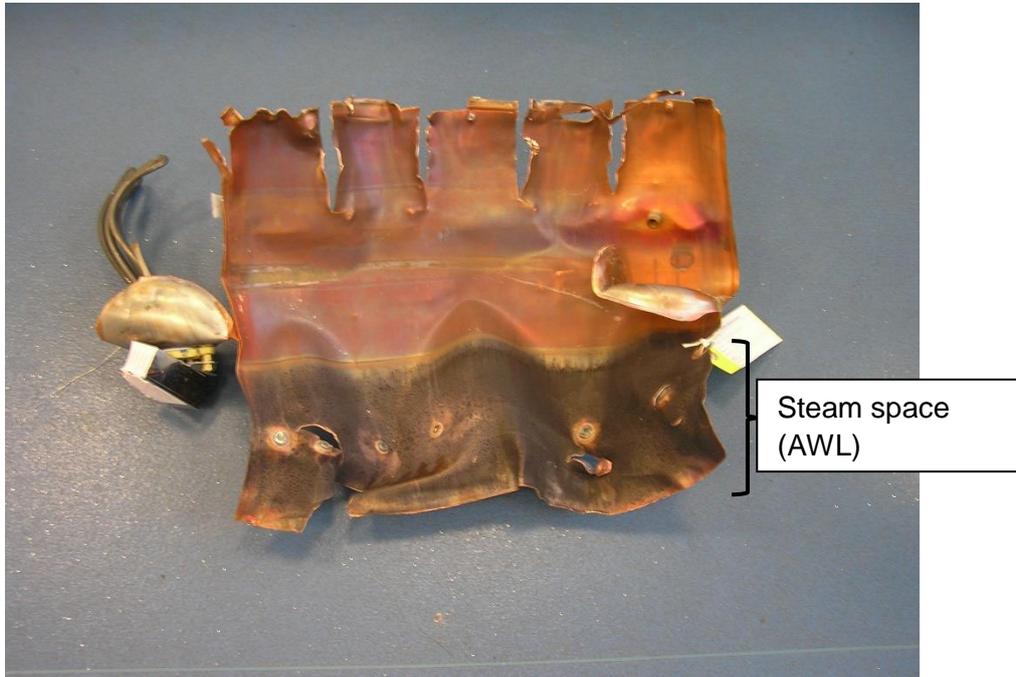
This boiler had been manufactured with pressed domes at both ends. The mean wall thickness of the boiler, taken from five measurements, was 1.38 mm, with individual values ranging from 1.35 mm to 1.41 mm. The boiler had failed catastrophically during testing, resulting in the cylinder almost completely opening out to form a relatively flat, rectangular sheet, Figure 20.

**Figure 20** Failed boiler vessel, manufacturer A (new) (Image No. P1012778.jpg)

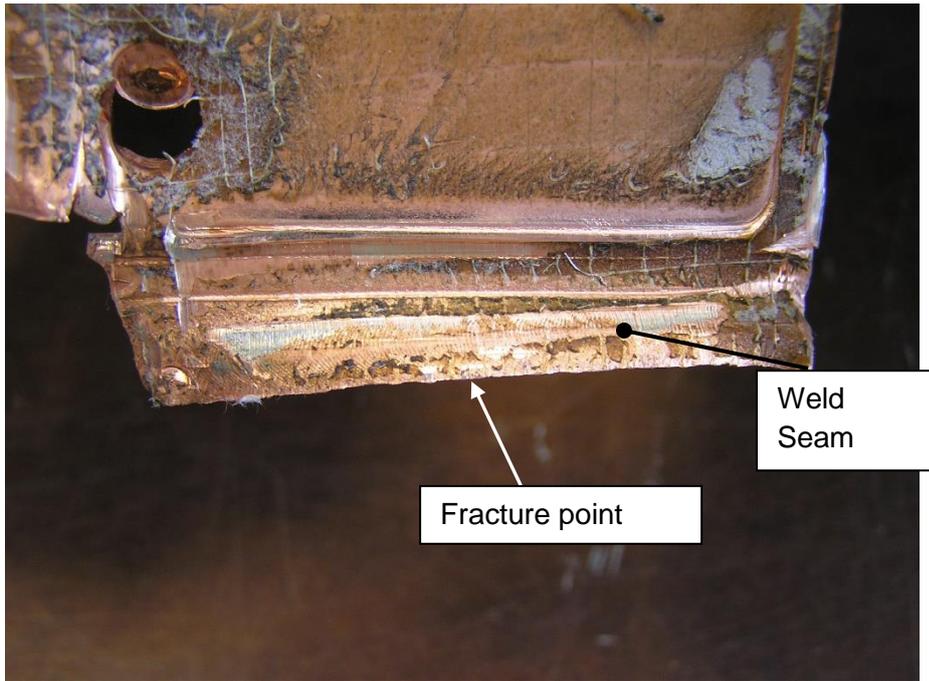
The fracture had occurred immediately adjacent to and along the length of the longitudinal butt weld, Figure 21.

**Figure 21 Fracture down one side of longitudinal weld seam** (Image No. P1012790.jpg)

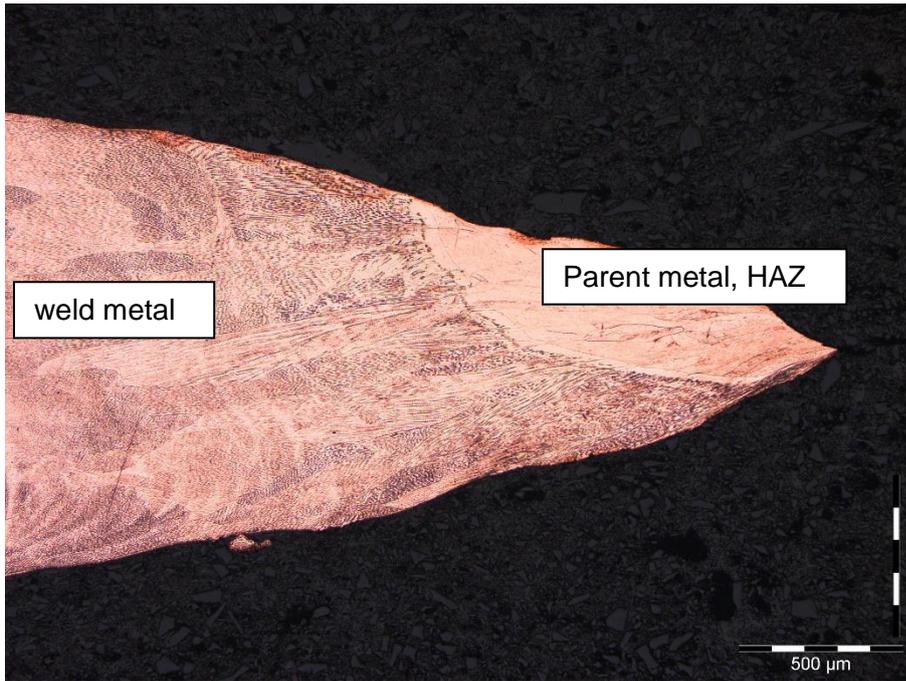
A metallographic sample was taken which incorporated a cross-section through the failure location adjacent to the longitudinal butt weld. Examination at high magnification, following sample preparation, revealed that the failure had occurred in the parent copper metal immediately next to the weld – not within the fused weld metal itself. At the failure point, the metal was heavily deformed. This was exhibited in the elongation of the crystal structures (grains) within the weld and the parent strip, Figure 22.

**Figure 22 Tapered ductile fracture point of vessel, adjacent to weld.** (Image No. 14373 met-1-1.jpg)

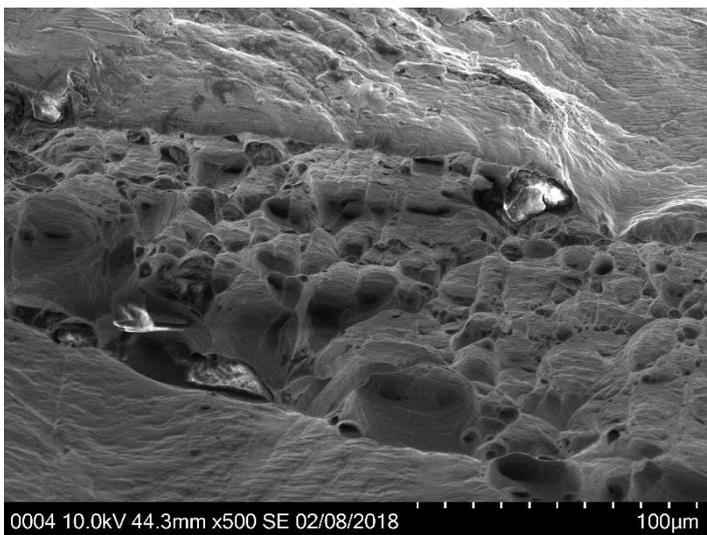
**Figure 24** Higher magnification electron micrograph showing ductile microvoid coalescence at failure point. (*Image No. 14373 fract\_0004.jpg*)

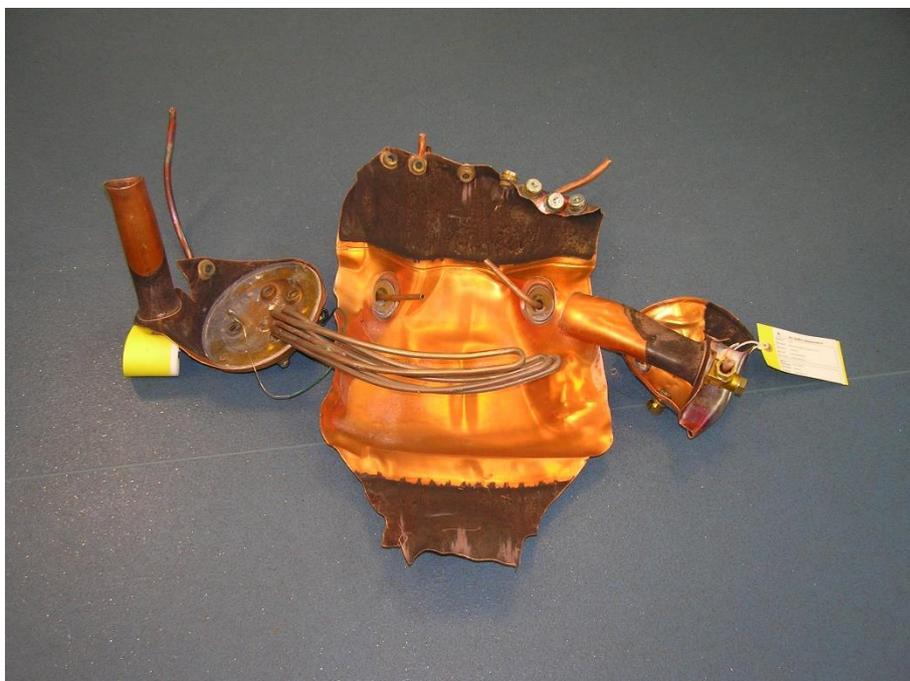
The boiler had undergone catastrophic failure due to overpressure. On this occasion the vessel had separated into three sections, Figure 27.

**Figure 27** Fractured vessel, manufacturer B (new), black zone corresponds to the AWL steam space. (Image No. P1012793.jpg)

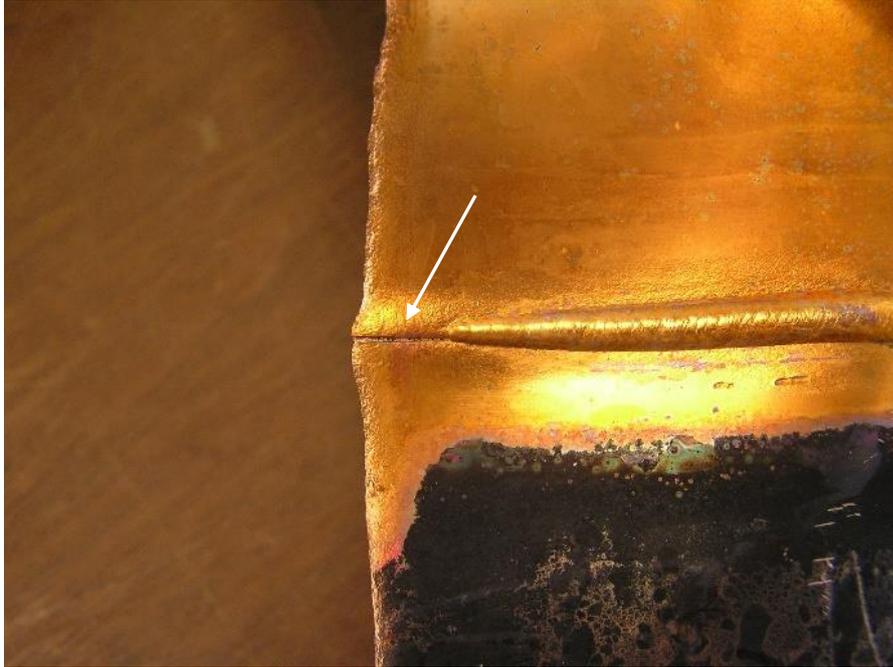
**Figure 28** Small lack-of-fusion defect (arrowed) on longitudinal weld on internal wall of vessel (external weld cap was intact). (Image No. P1012801.jpg)

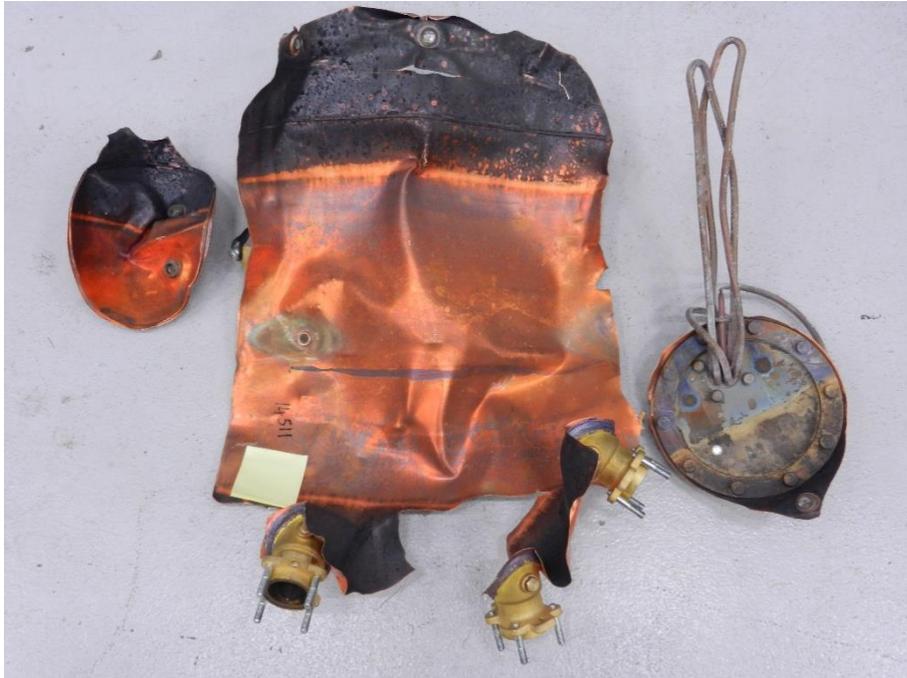
**Figure 31** Failure of boiler vessel, manufacturer C (new) (Image No. DSCN5973.jpg)

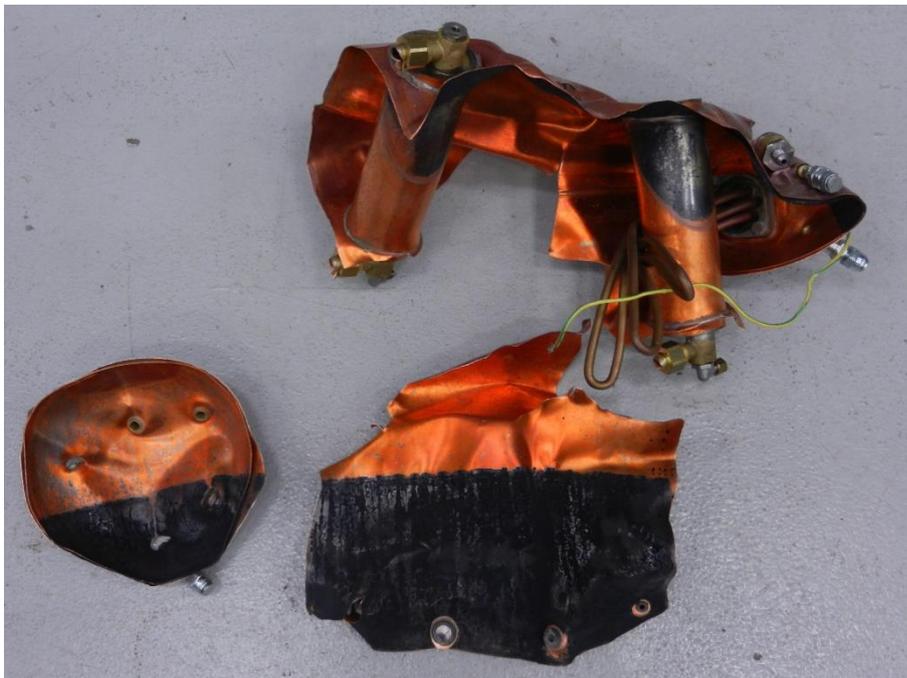
**Figure 34** Fractured boiler vessel, manufacturer D (new) (Image No. DSCN5960.jpg)

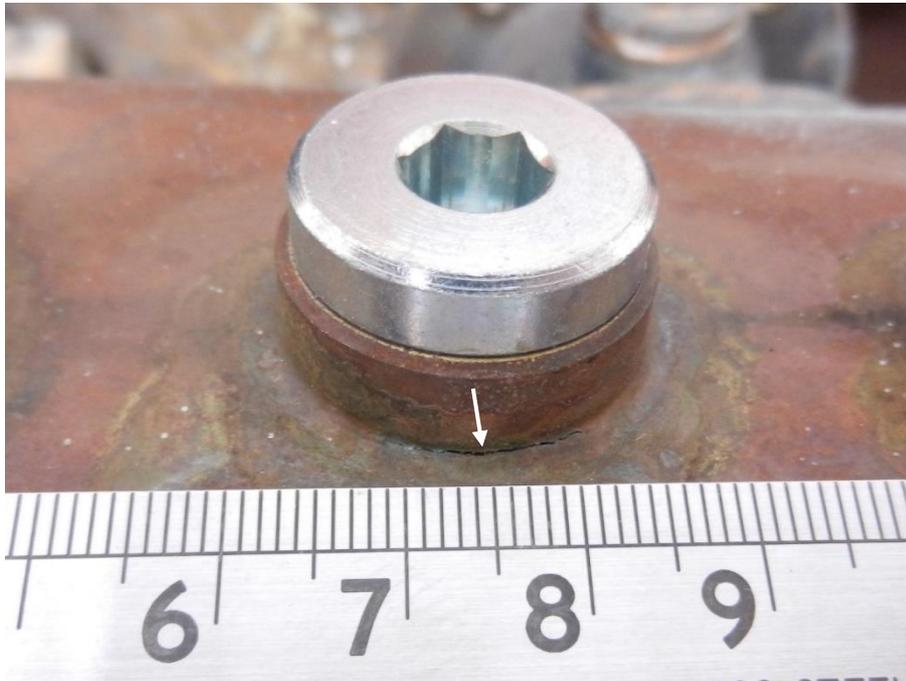
**Figure 37** Crack in base of brazed port fitting (Image No. DSCN5995.jpg)

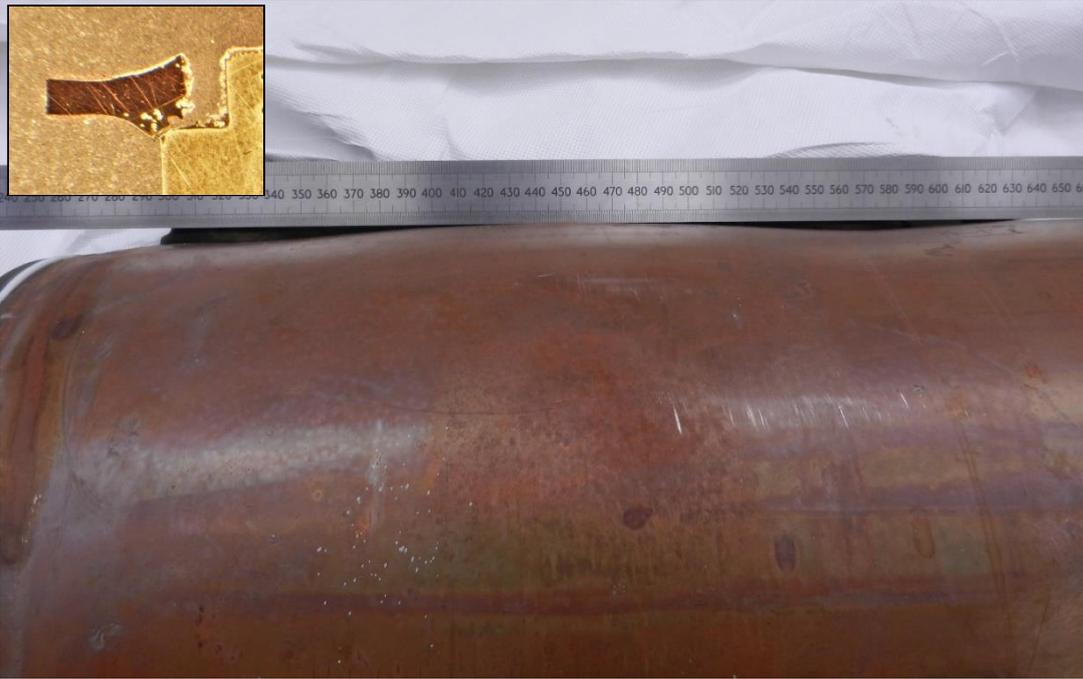
**Figure 38** Showing post-test bulging of vessel (against straight edge of rule) (Image No. DSCN5990.jpg)

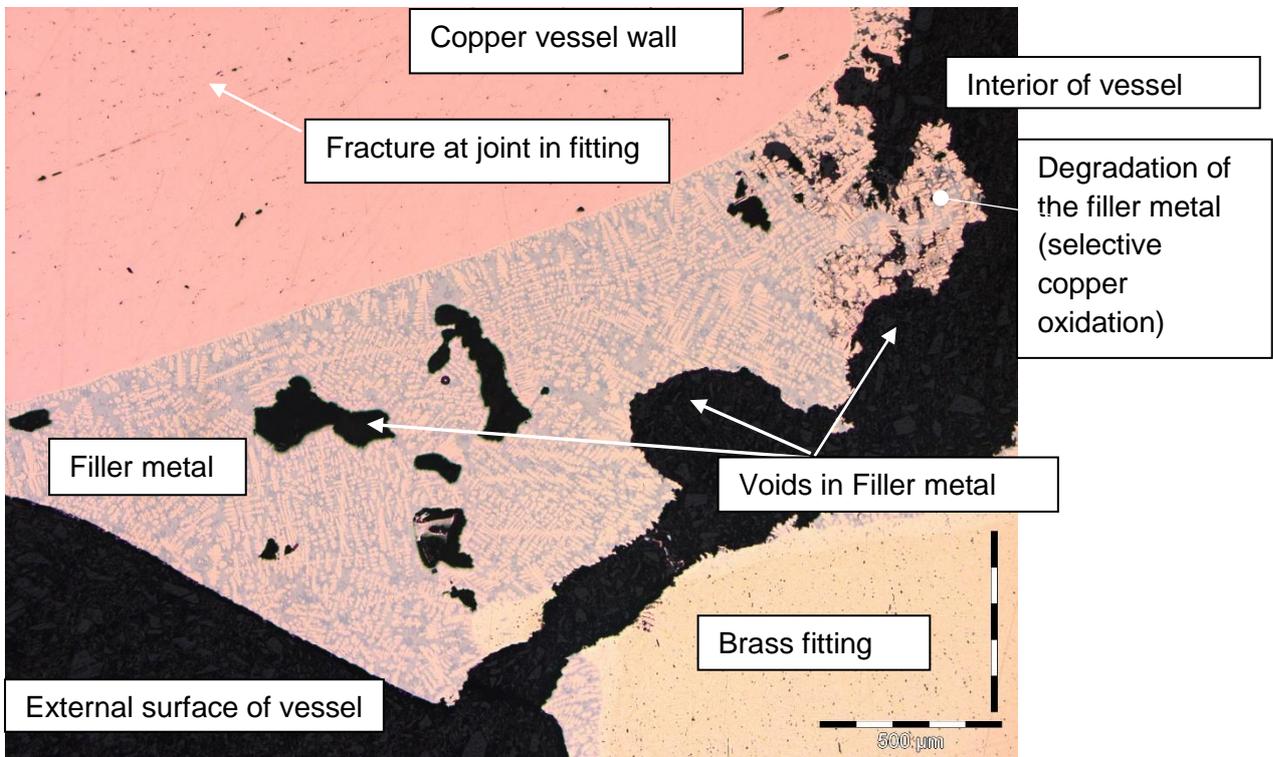
**Figure 39** Cross section through cracked brazed joint (inset shows fractured joint at low magnification) (Image No. 14035 met1-1.jpg)

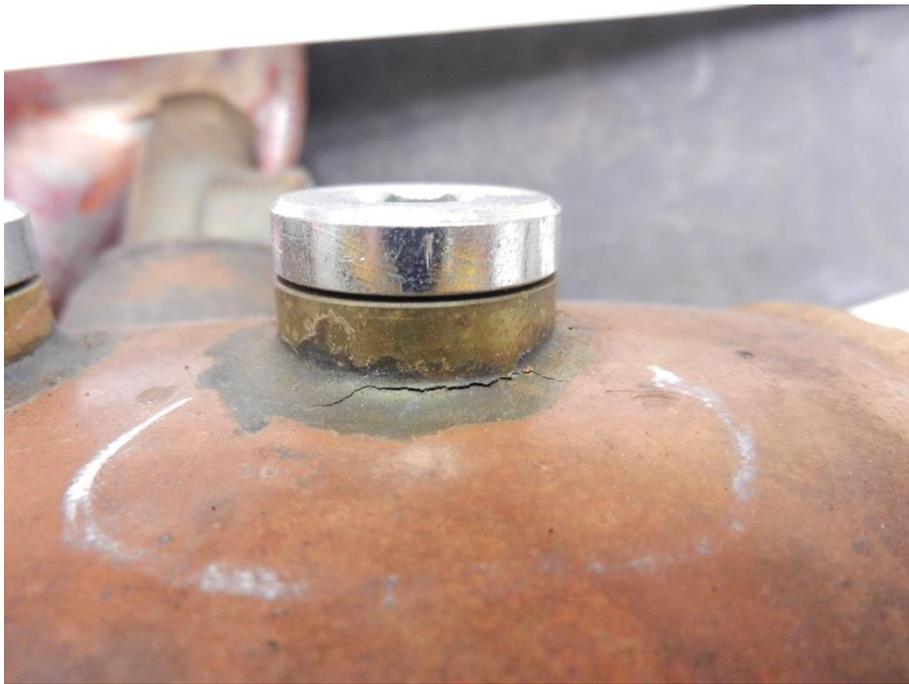
**Figure 42** Crack through brazed joint in port fitting (*Image No. DSCN5938.jpg*)

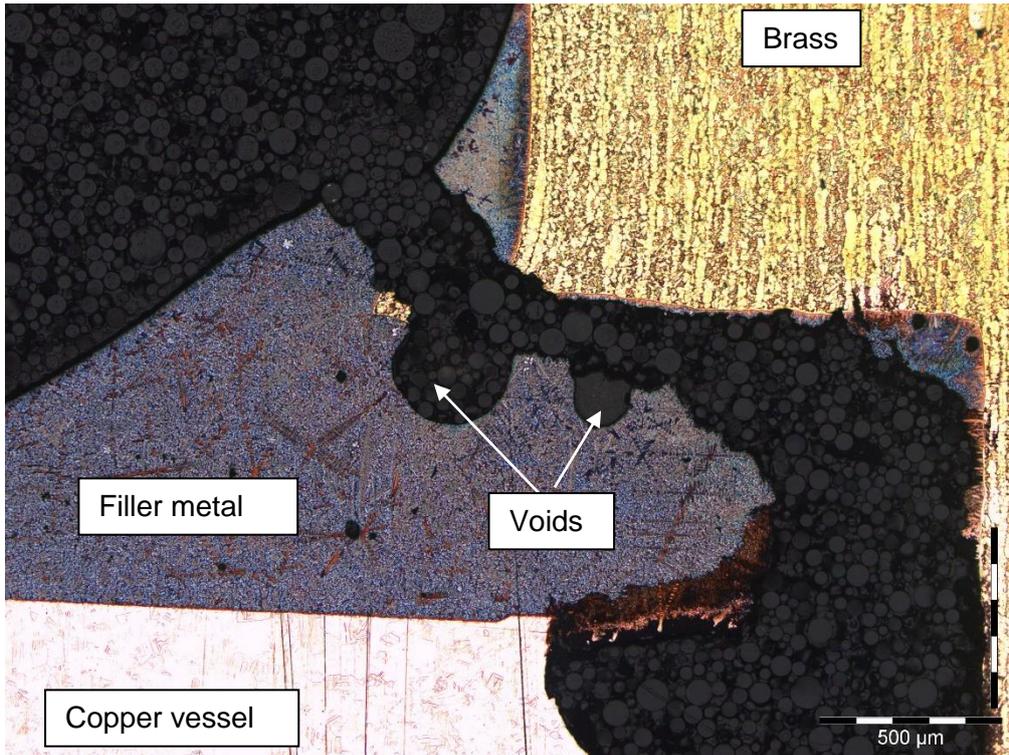
**Figure 43** Cross section through fracture in filler metal (sample has been etched)  
(Image No. 14133 met-2-2.jpg)

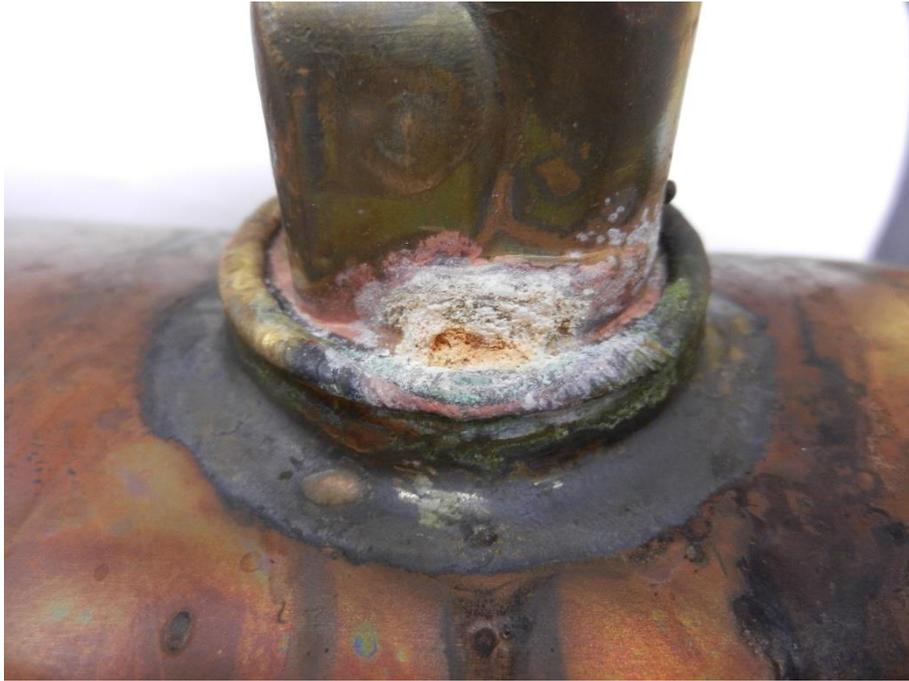
**Figure 44 Deposits on outer surface of one of the heat exchangers** (Image No. DSCN5933.jpg)

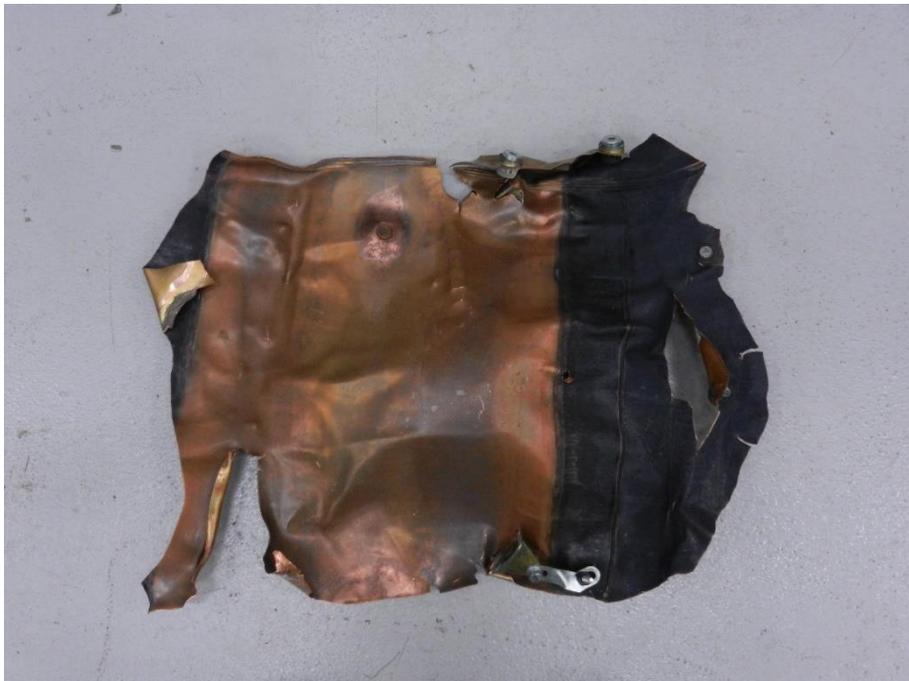
**Figure 47** Section of fractured boiler vessel (Image No. DSCN5957.jpg)

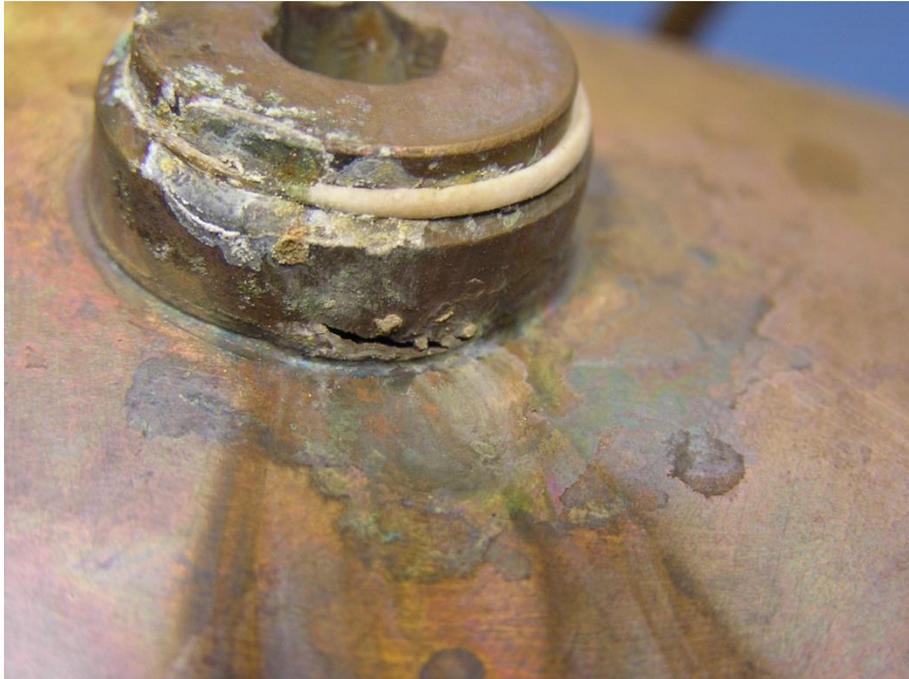
**Figure 50** Cracking in wall of fitting at drain port (Image No. P1012939.jpg)

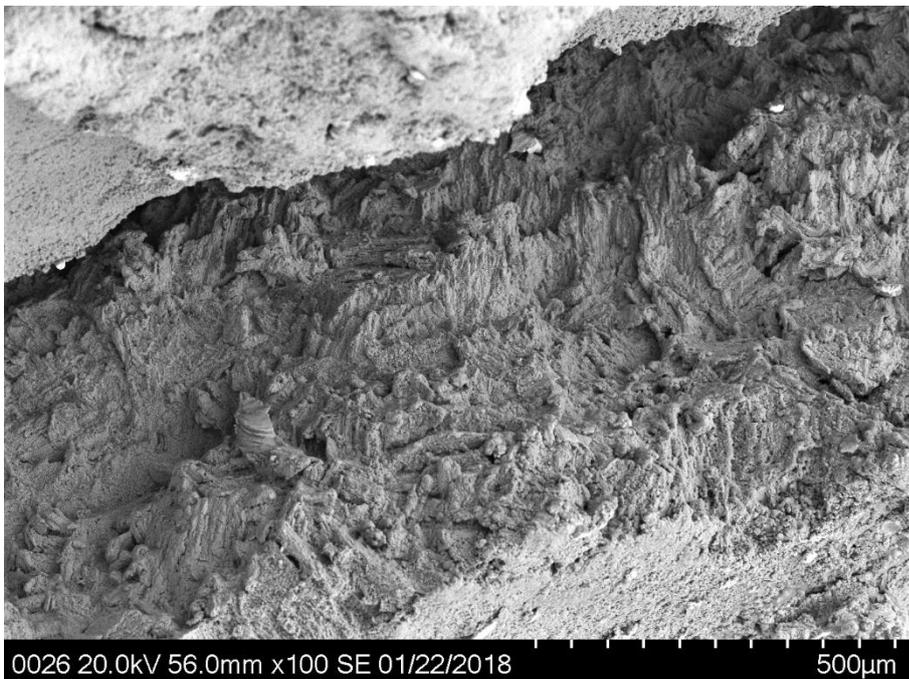
**Figure 51** Fracture surface of the crack (Image No. 14430\_0026.jpg)

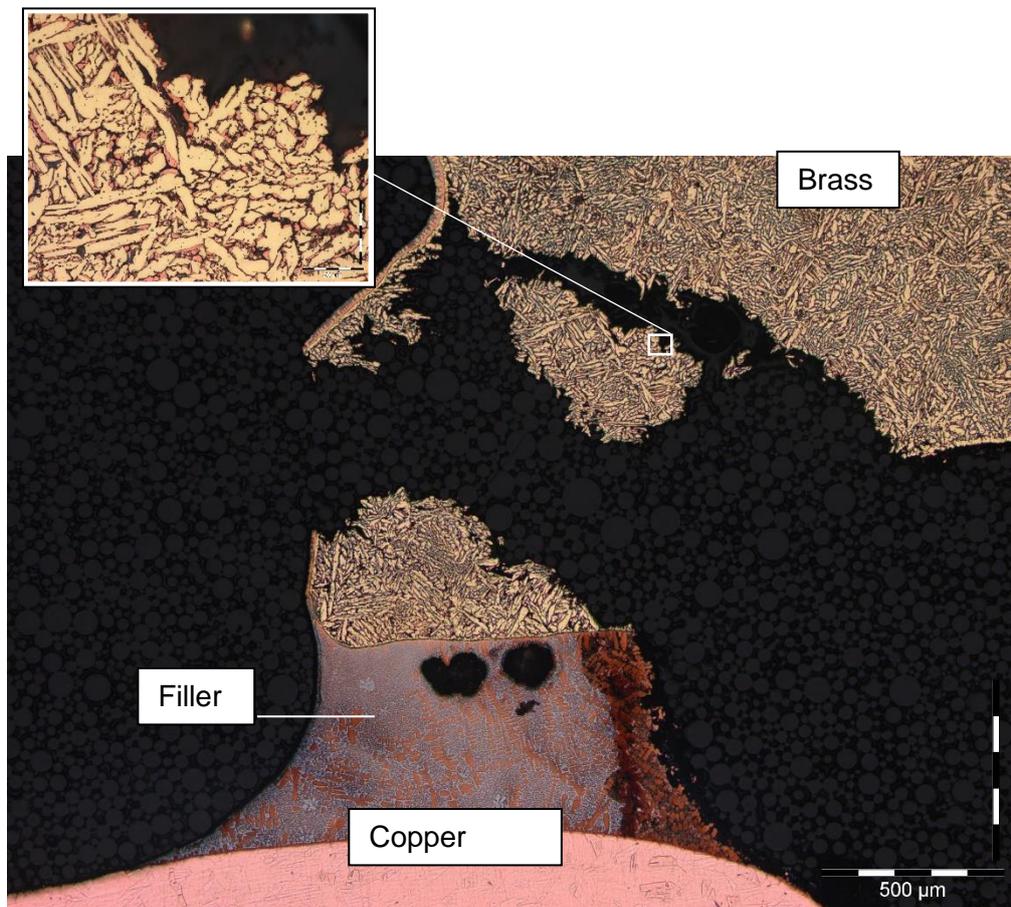
**Figure 52** Cross-section through fractured drain port fitting (inset showing pink copper-rich regions due to zinc depletion (dezincification)) (Images No. 14430 met 2-1a, 14430 met 2-5.jpg)

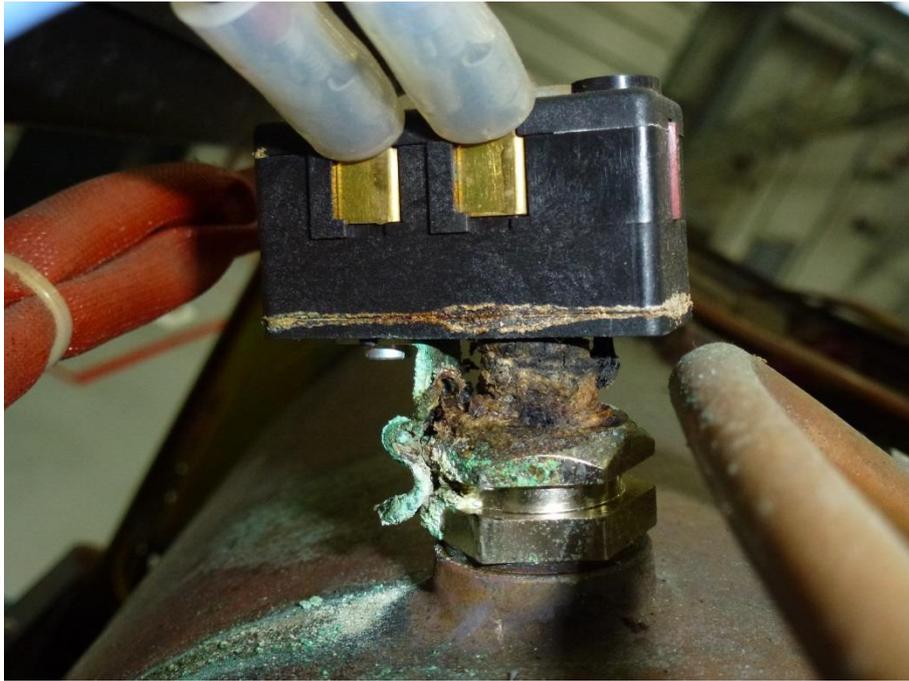
**Figure 54 Corroded over-temperature switch** (Image No. P1050563.jpg)
