# **Risk control for small pressure vessels: café boilers, bench-top autoclaves, and model steam engines**

Prepared by researchers at the  
**Health and Safety Executive**

**RR1177 (2022)**  
**Research Report**

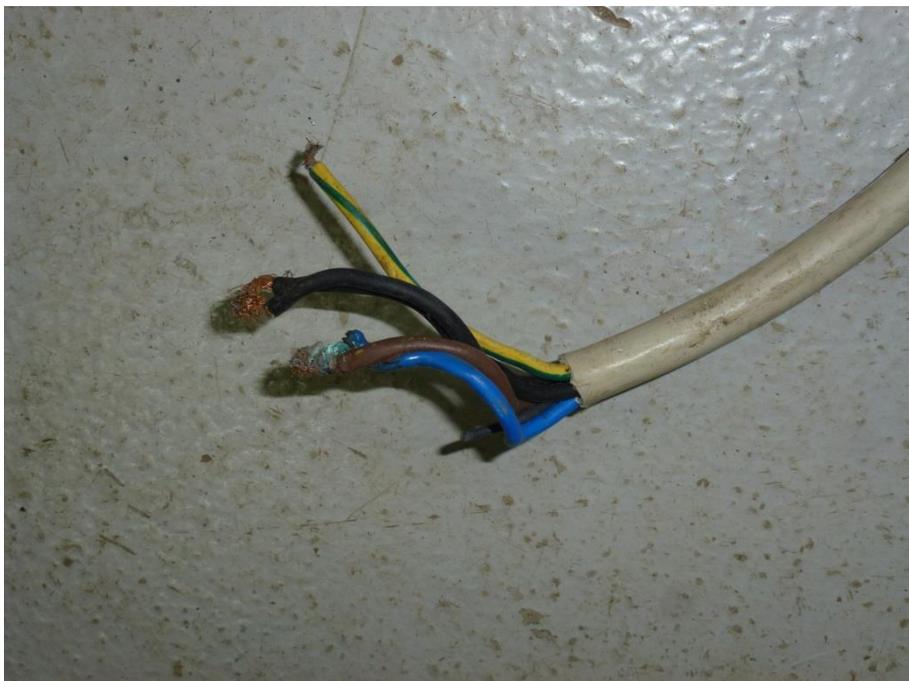
**Figure 55 Supply cable conversion three-phase to single phase** (Image No. P1050957.jpg)

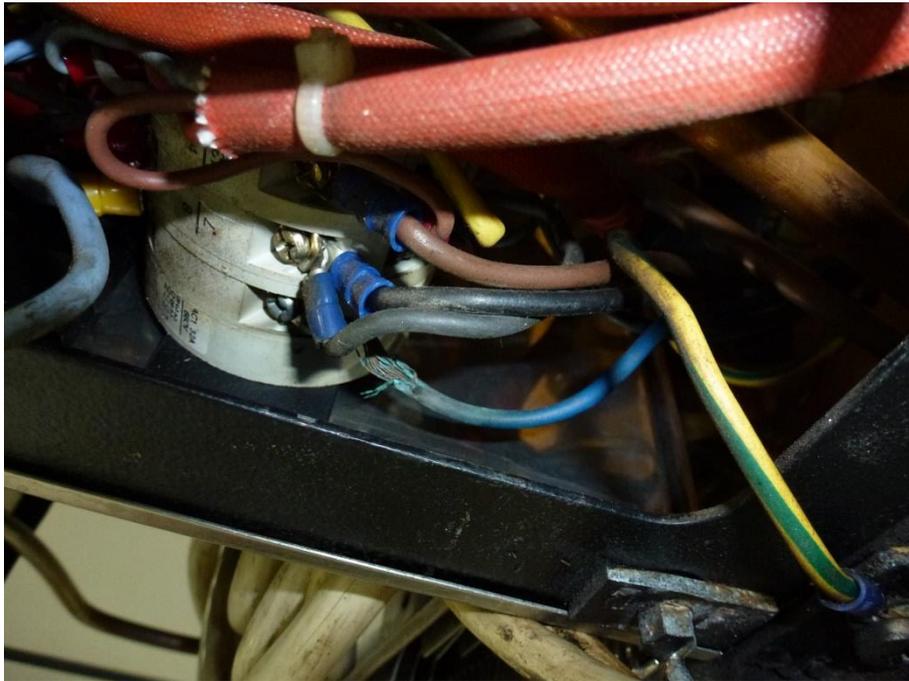
**Figure 56** Boiler end conversion three-phase to single phase *(Image No. P1050979.jpg)*

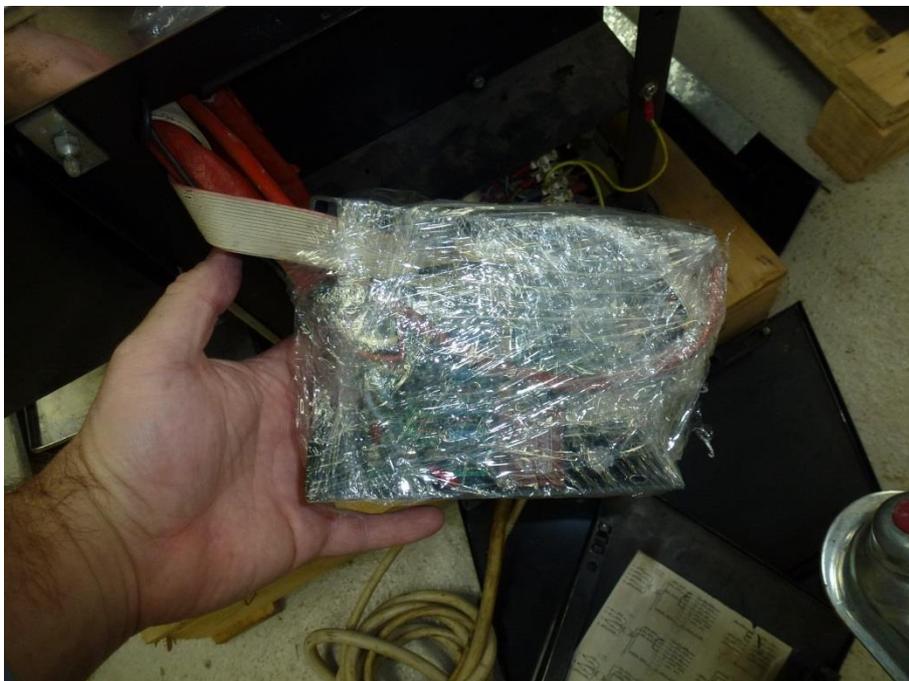
**Figure 57** Control PCB wrapped in Clingfilm *(Image No. P1050959.jpg)*

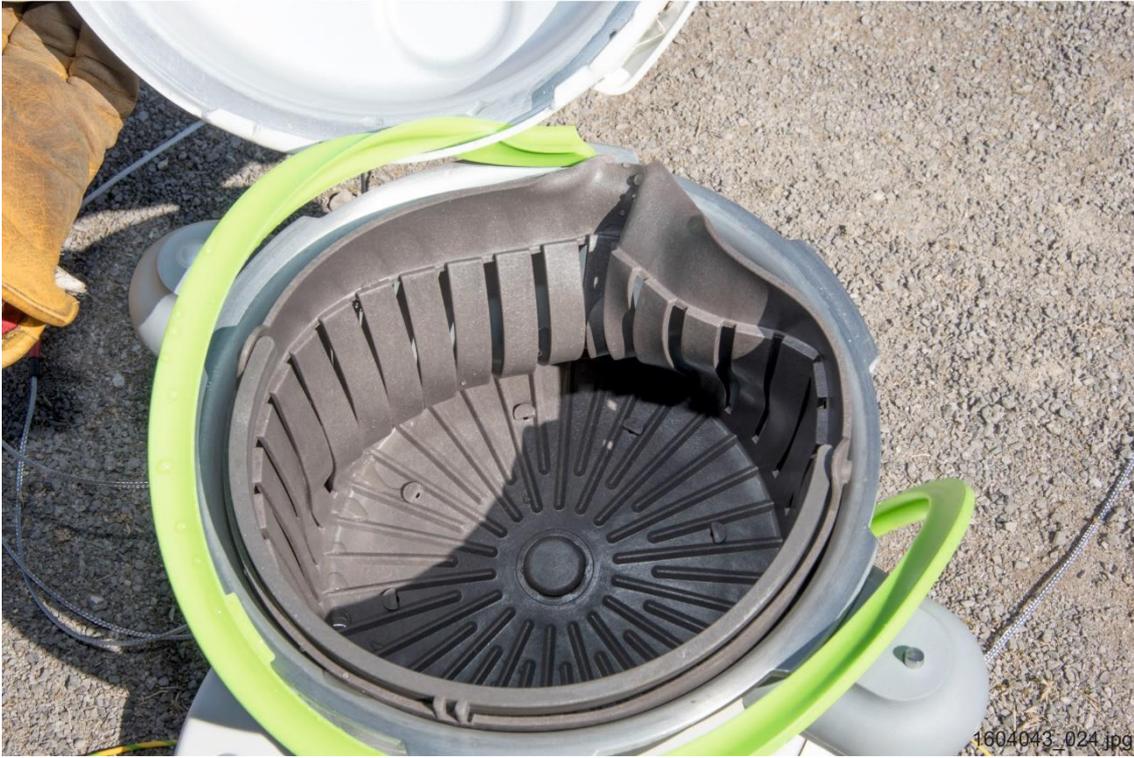
**Figure 60** Deformation of internal carrier basket, new autoclave 14427 (Image No. AIS 1604043\_024)

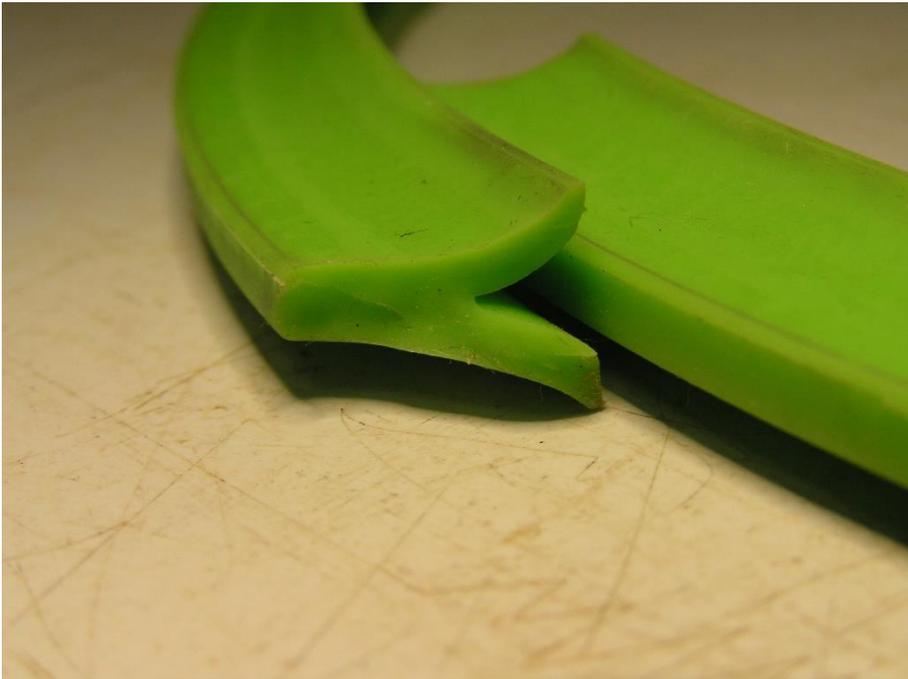
**Figure 62** Ruptured gasket from autoclave 14427 (*Image No. P1012991.jpg*)

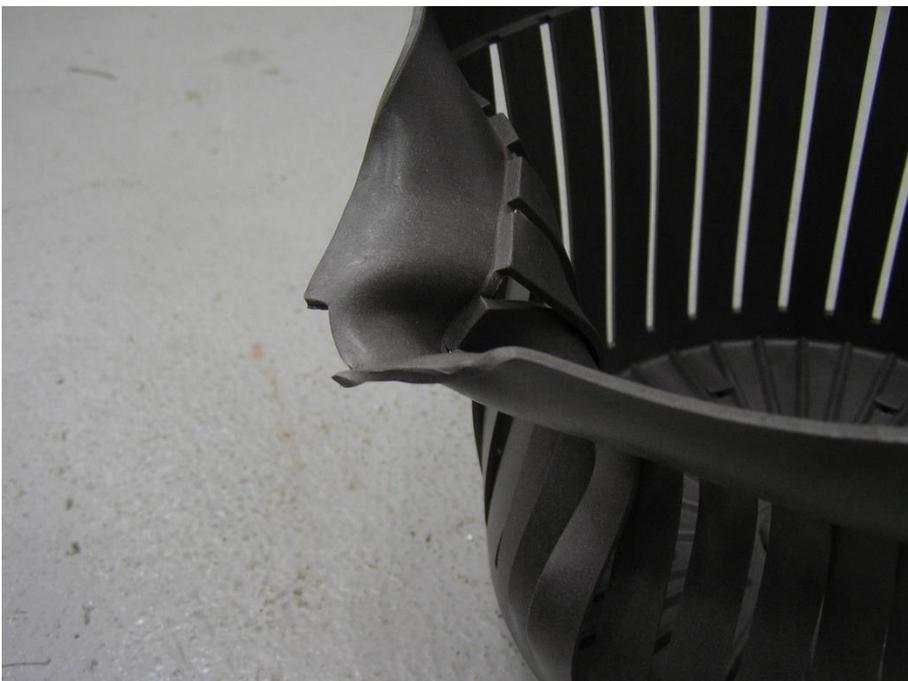
**Figure 63** Distorted basket from autoclave 14427 (*Image No. P1012985.jpg*)

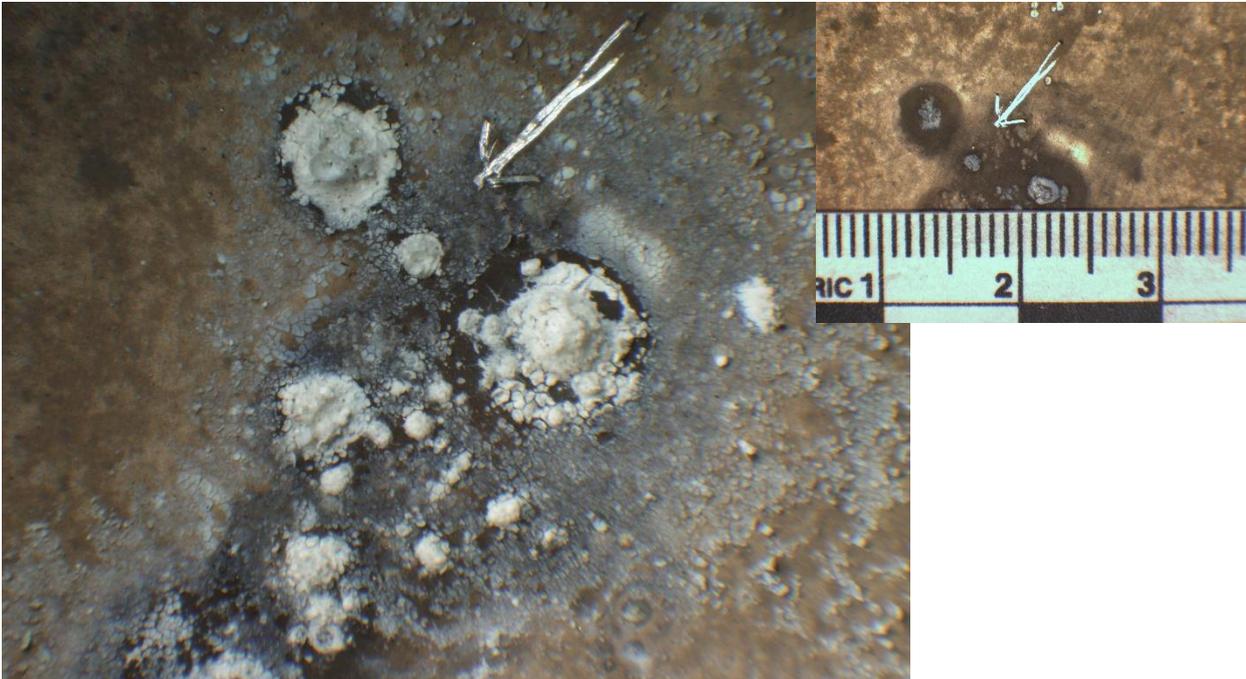
**Figure 66** Showing powdery caps overlying pits (inset) in base of autoclave 14426  
(Image No. 14426-5, and -7.jpg)

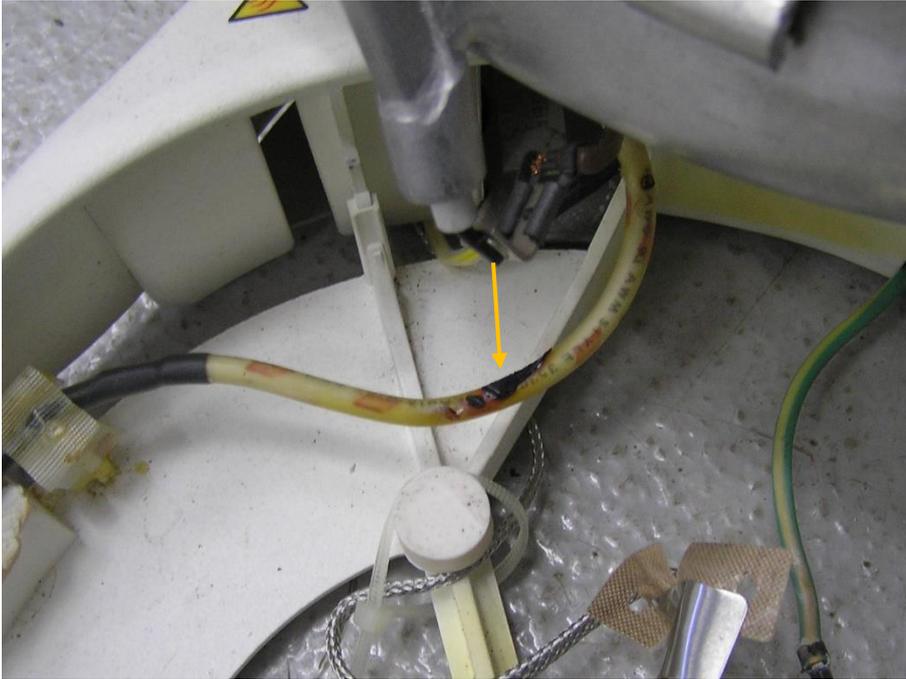
**Figure 67 Heat damage to electrical fitting (arrow) in plastic base of autoclave 14426** (Image No. P1013001.jpg)
