# **Risk control for small pressure vessels: café boilers, bench-top autoclaves, and model steam engines**

Prepared by researchers at the  
**Health and Safety Executive**

**RR1177 (2022)**  
**Research Report**

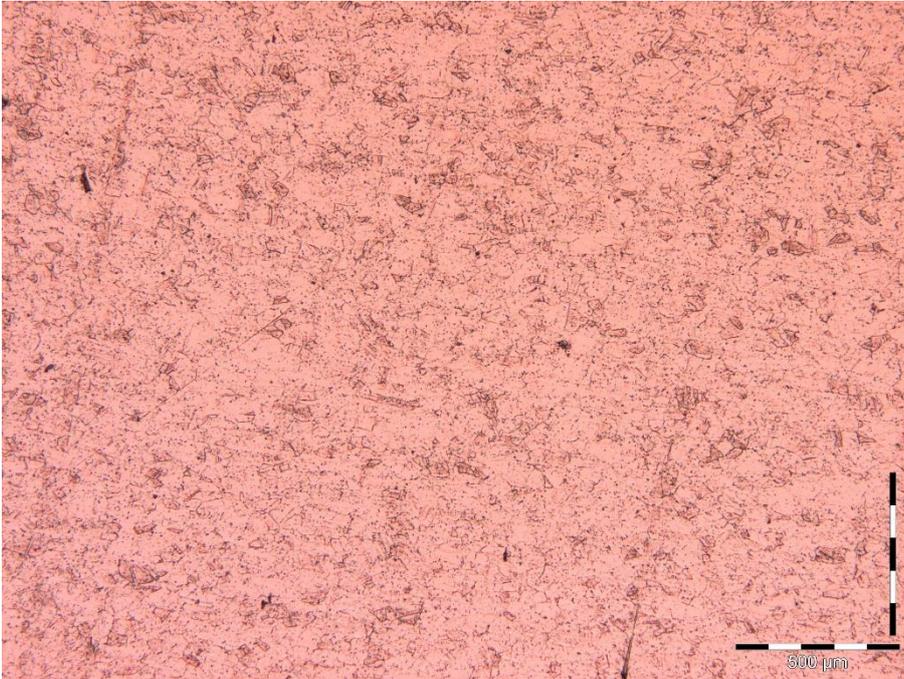
A metallographic cross-section was prepared from the intact longitudinal butt seam weld to demonstrate the range of microstructures and hardness variation across the weld. Distant from the weld, within the parent copper strip, the microstructure comprised a fine equiaxed grain structure, Figure 10.

**Figure 10** Fine equiaxed grain structure in parent strip (Image No. 14134 met1-3.jpg)

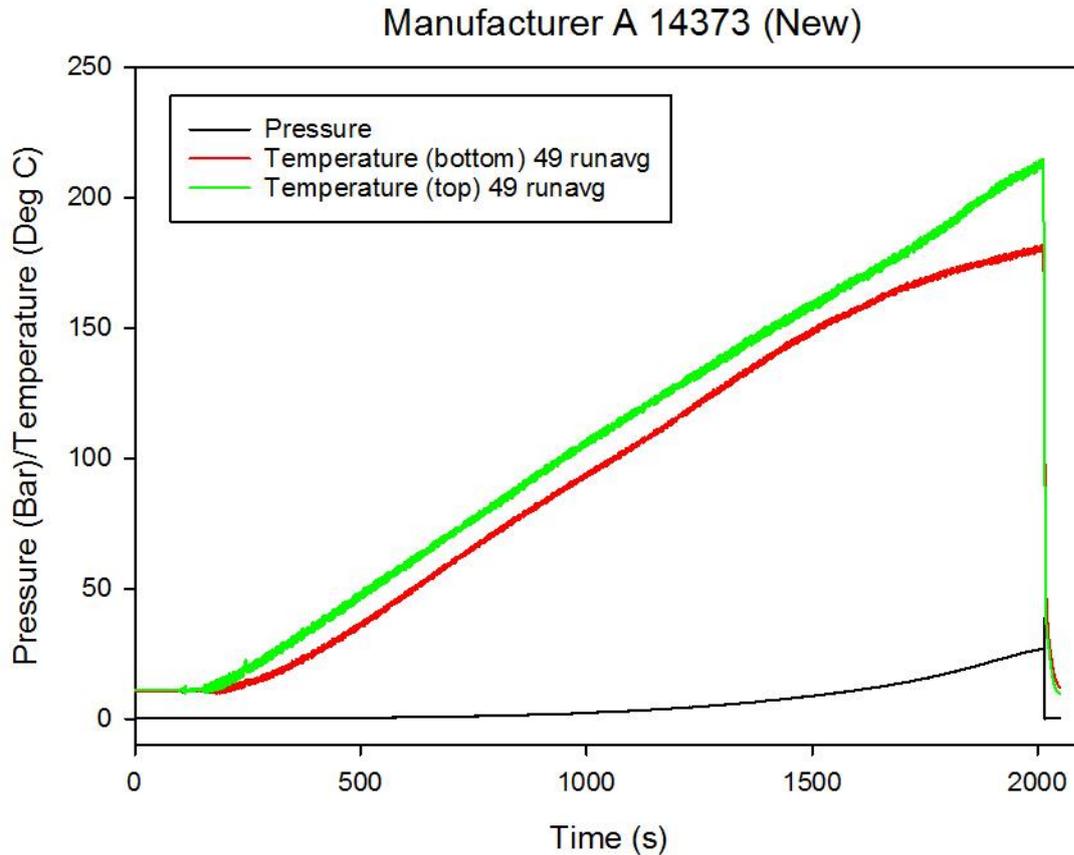
During the test, pressure and temperature increased steadily until catastrophic failure of the boiler occurred at 27.0 bar as shown in Figure 18.

**Figure 18 Pressure and Temperature Results – manufacturer A (new)**

A momentary peak of 38.9 bar was recorded during failure, however in the preceding data points the pressure had dropped to less than 2 bar, suggesting that failure had already occurred. It is unknown what event caused this secondary peak; however, possible explanations include a pressure wave, or a physical impact experienced by the transducer or cable. A higher logging rate may have provided further information, but the primary purpose of the testing was to determine the pressure within the vessel when failure occurred, rather than to capture pressure events during failure.

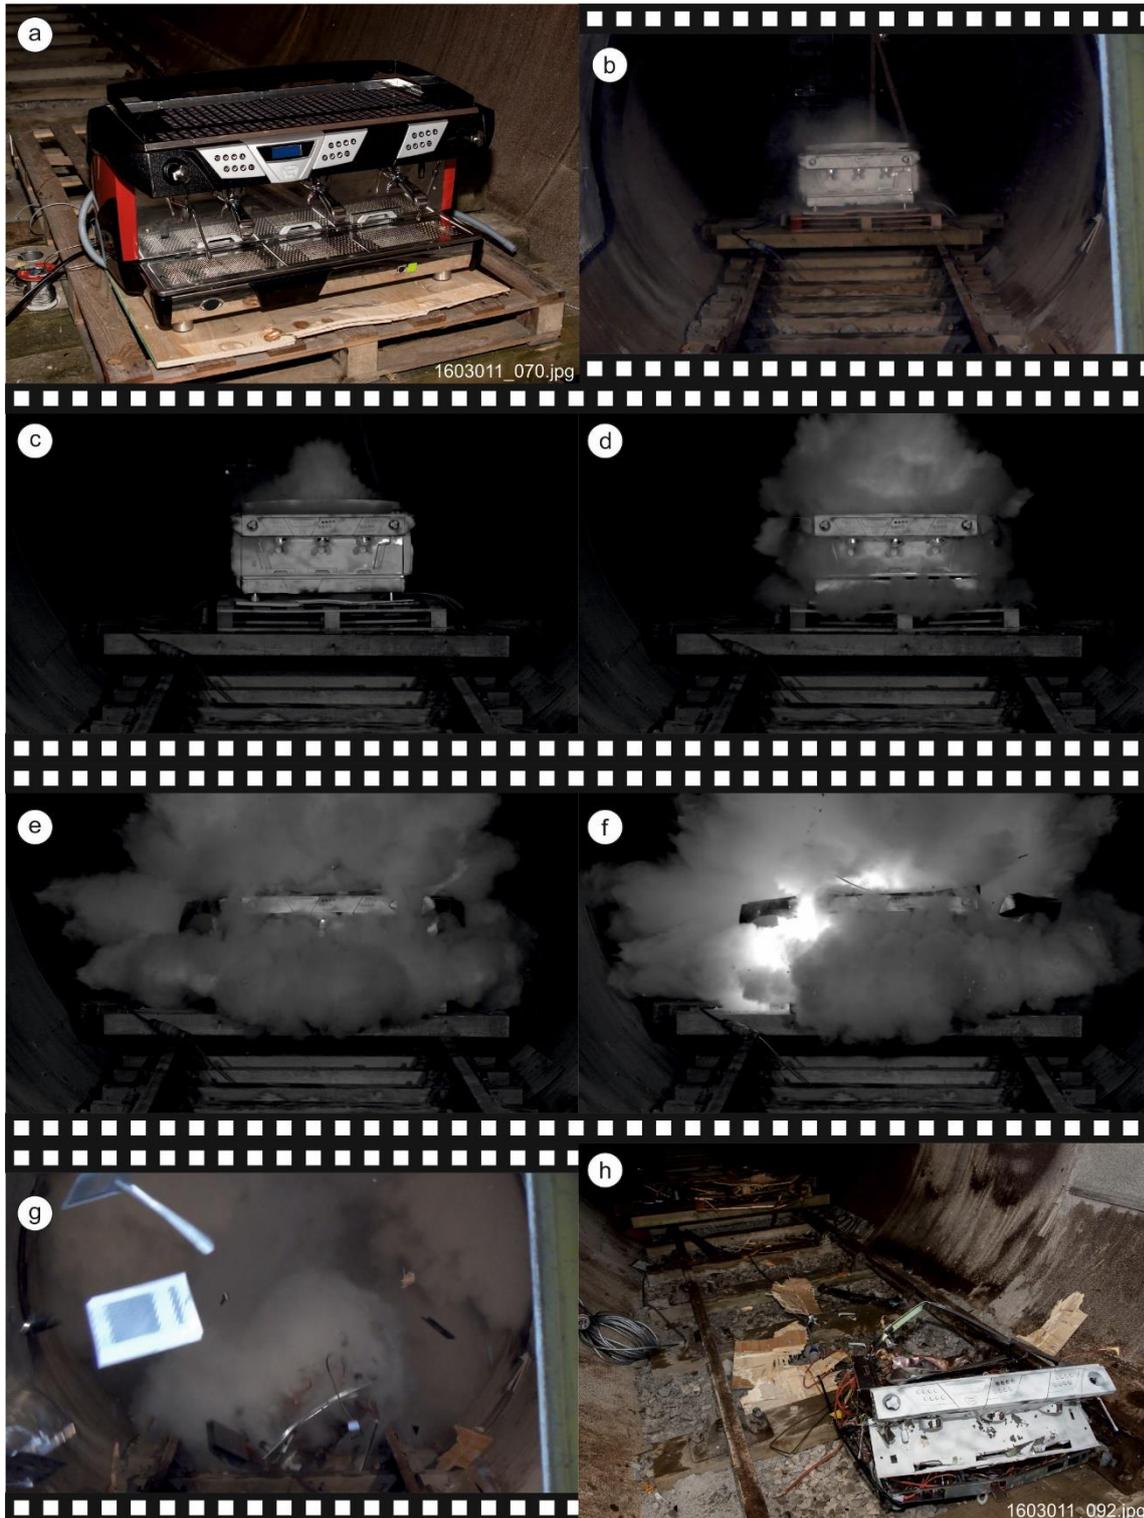
**Figure 19 Images from the test – manufacturer A (new)**

Insets b to g are sequences taken from the high-speed (black and white images) and high-definition video footage (colour images). Note the bright flash in inset image f. This was thought to be due to a severing of the power cable or an internal short circuit that occurred during failure. The residual current device (RCD) protecting the generator had tripped during the failure event.

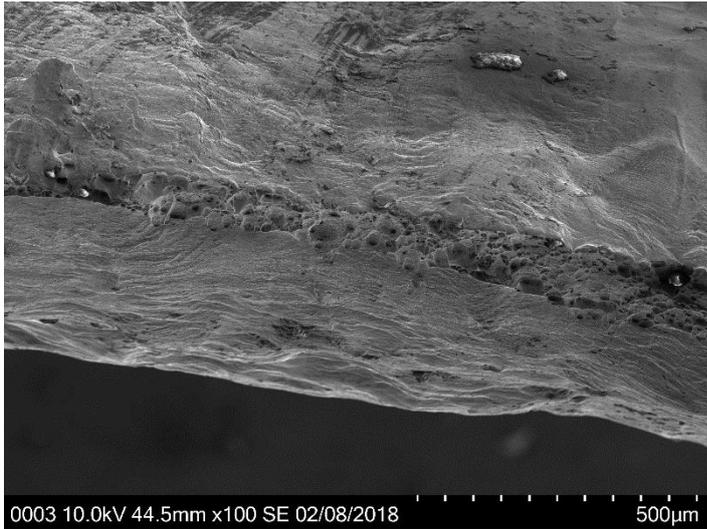
To confirm the mode of fracture, a sample was examined at high magnification using the SEM. Figures 23 and 24 show low and high magnification images of the fracture. It was clear that the fracture mode had been by ductile failure, whereby the wall thickness had become progressively thin by plastic deformation under the applied loading until final fracture occurred by microvoid coalescence<sup>12</sup>.

**Figure 23** Electron micrograph – looking edge-on to the fracture. (*Image No. 14373 fract\_0003.jpg*)

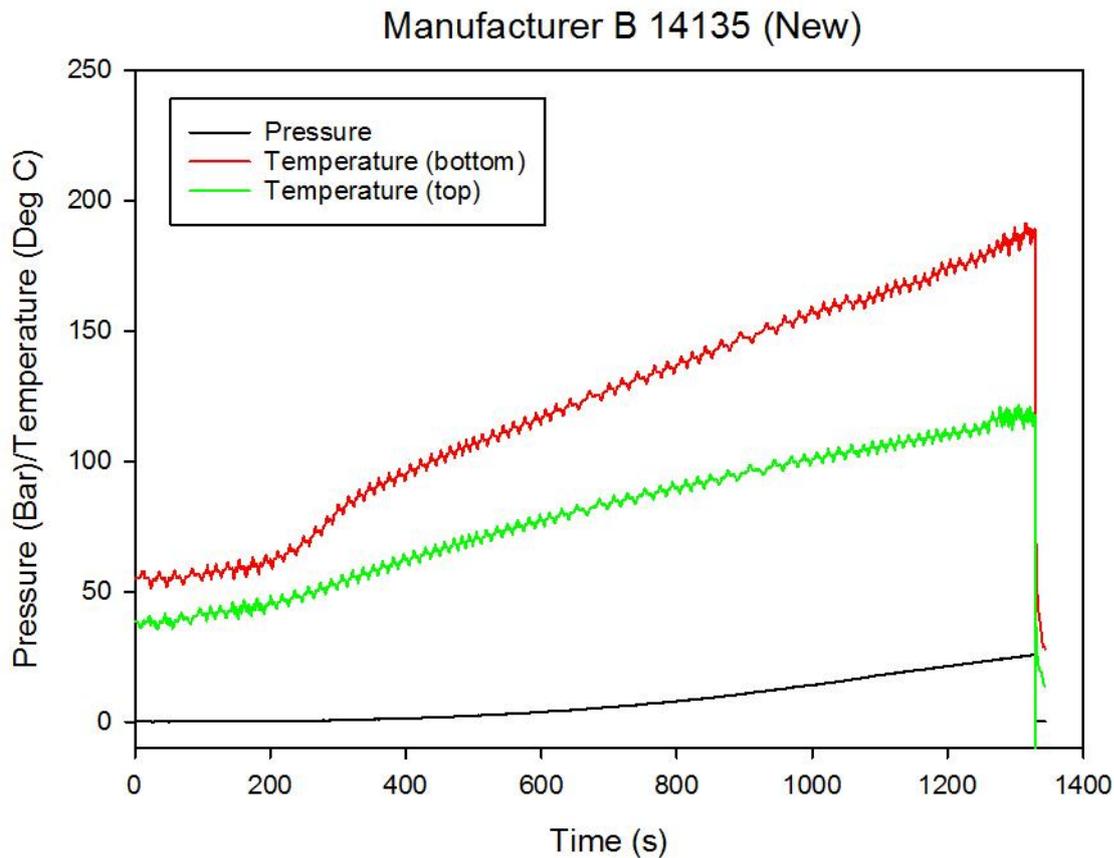
**Figure 25 Pressure and Temperature Results – manufacturer B (new)**

During the remaining period of the testing, the pressure and temperature increased steadily until catastrophic failure of the boiler occurred at 25.8 bar. A momentary peak of 28.51 bar had been recorded immediately upon failure, but this has been discounted as it was a single value and was also accompanied by a negative temperature spike. Values immediately prior to failure had been steadily rising through 25.7 bar to 25.8 bar.

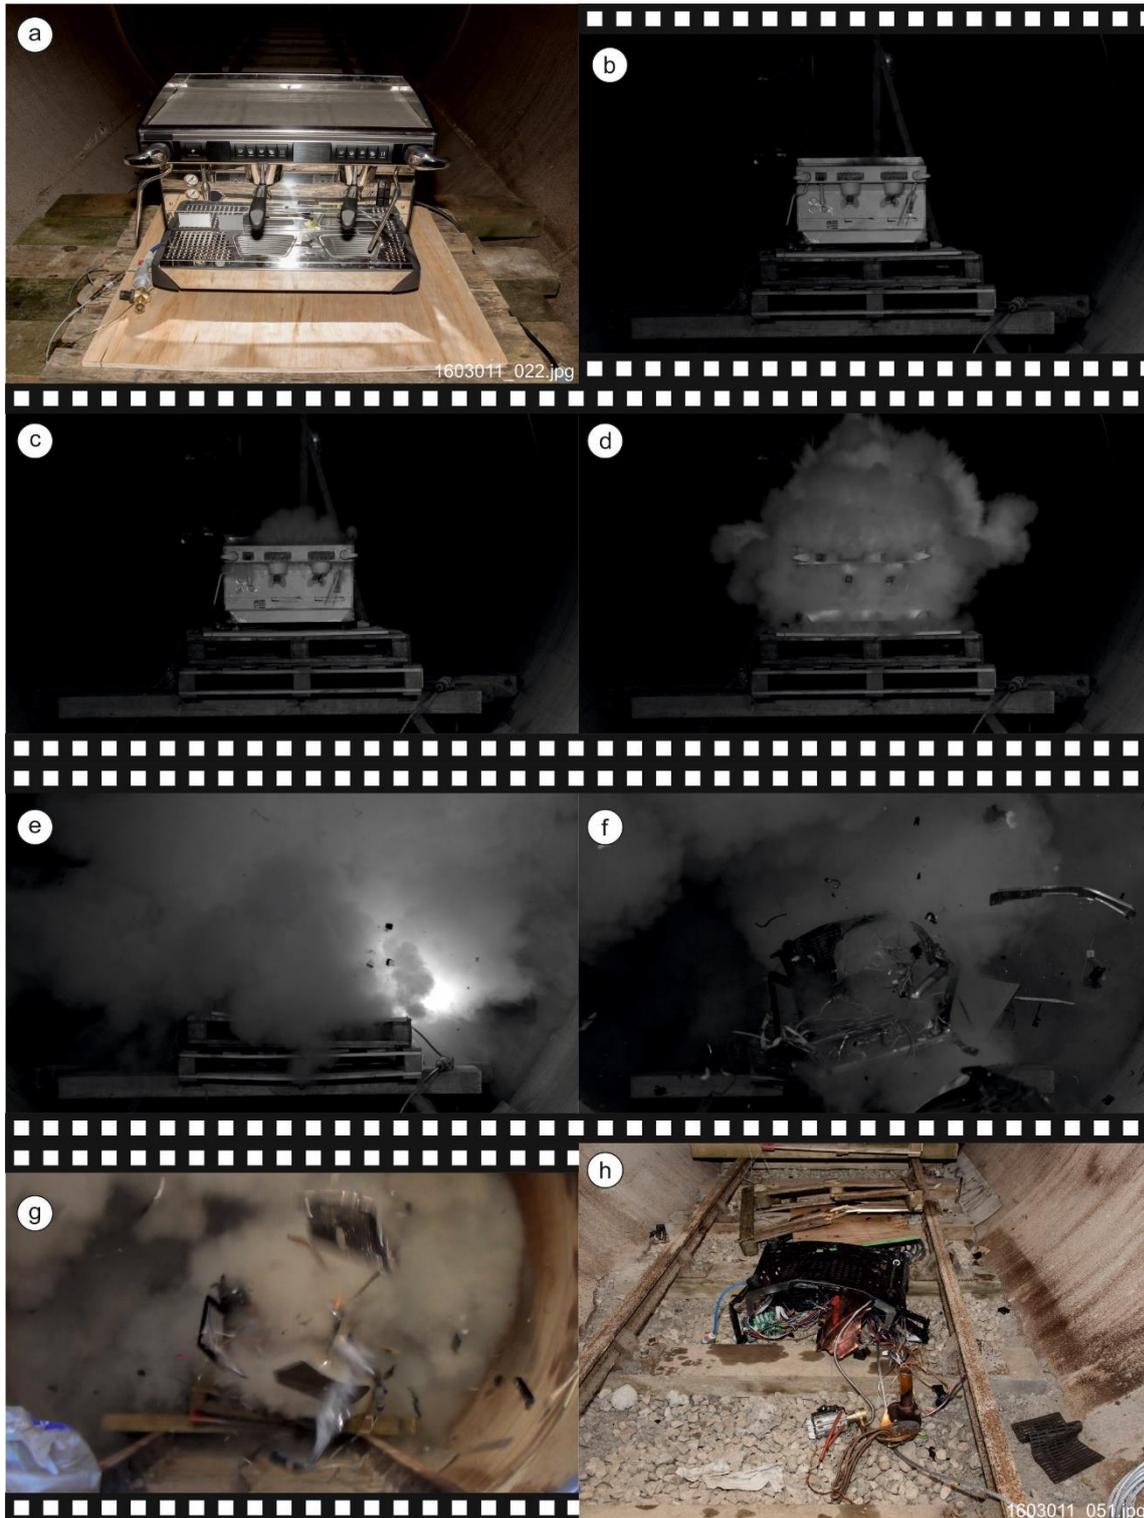
**Figure 26 Images from the test – manufacturer B (new)**

Insets b to g are sequences taken from the high-speed (black and white images) and high-definition video footage (colour images). Note the bright flash in inset image e. Again, this was thought to be due to a severing of the power cable or an internal short circuit that occurred during failure. The residual current device (RCD) protecting the generator had tripped during the failure event.

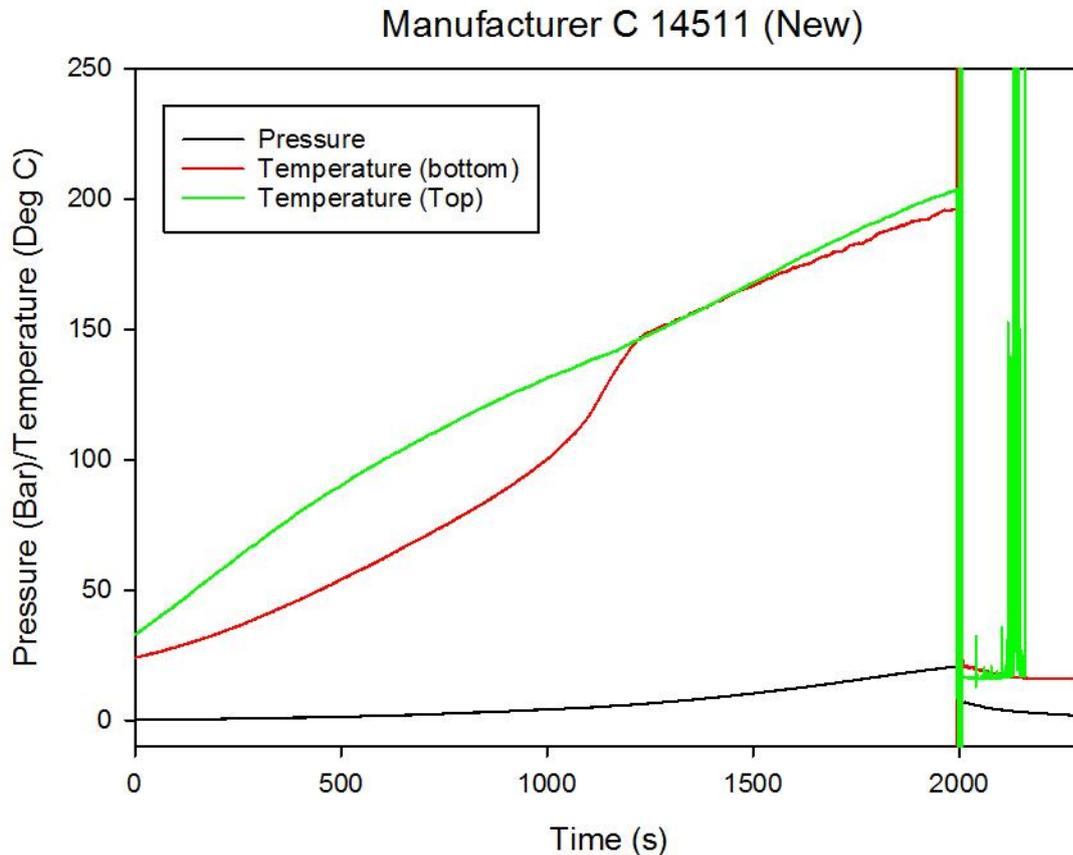
Testing proceeded without interruption. Pressure and temperature increased steadily during the test. There was no visible indication of overpressure observed on the video footage prior to catastrophic failure of the boiler (at 20.6 bar) is shown in Figure 29.

**Figure 29 Pressure and Temperature Results – manufacturer C (new)**

Severing of cables during the explosion is likely to be the reason for the spikes indicated on the thermocouple readings. The pressure transducer cable had also been severed, but the output did not return to zero immediately. It became clear during post-test examination that the pressure decay indicated after failure did not occur as the interconnecting hose had been severed and was open to atmosphere.

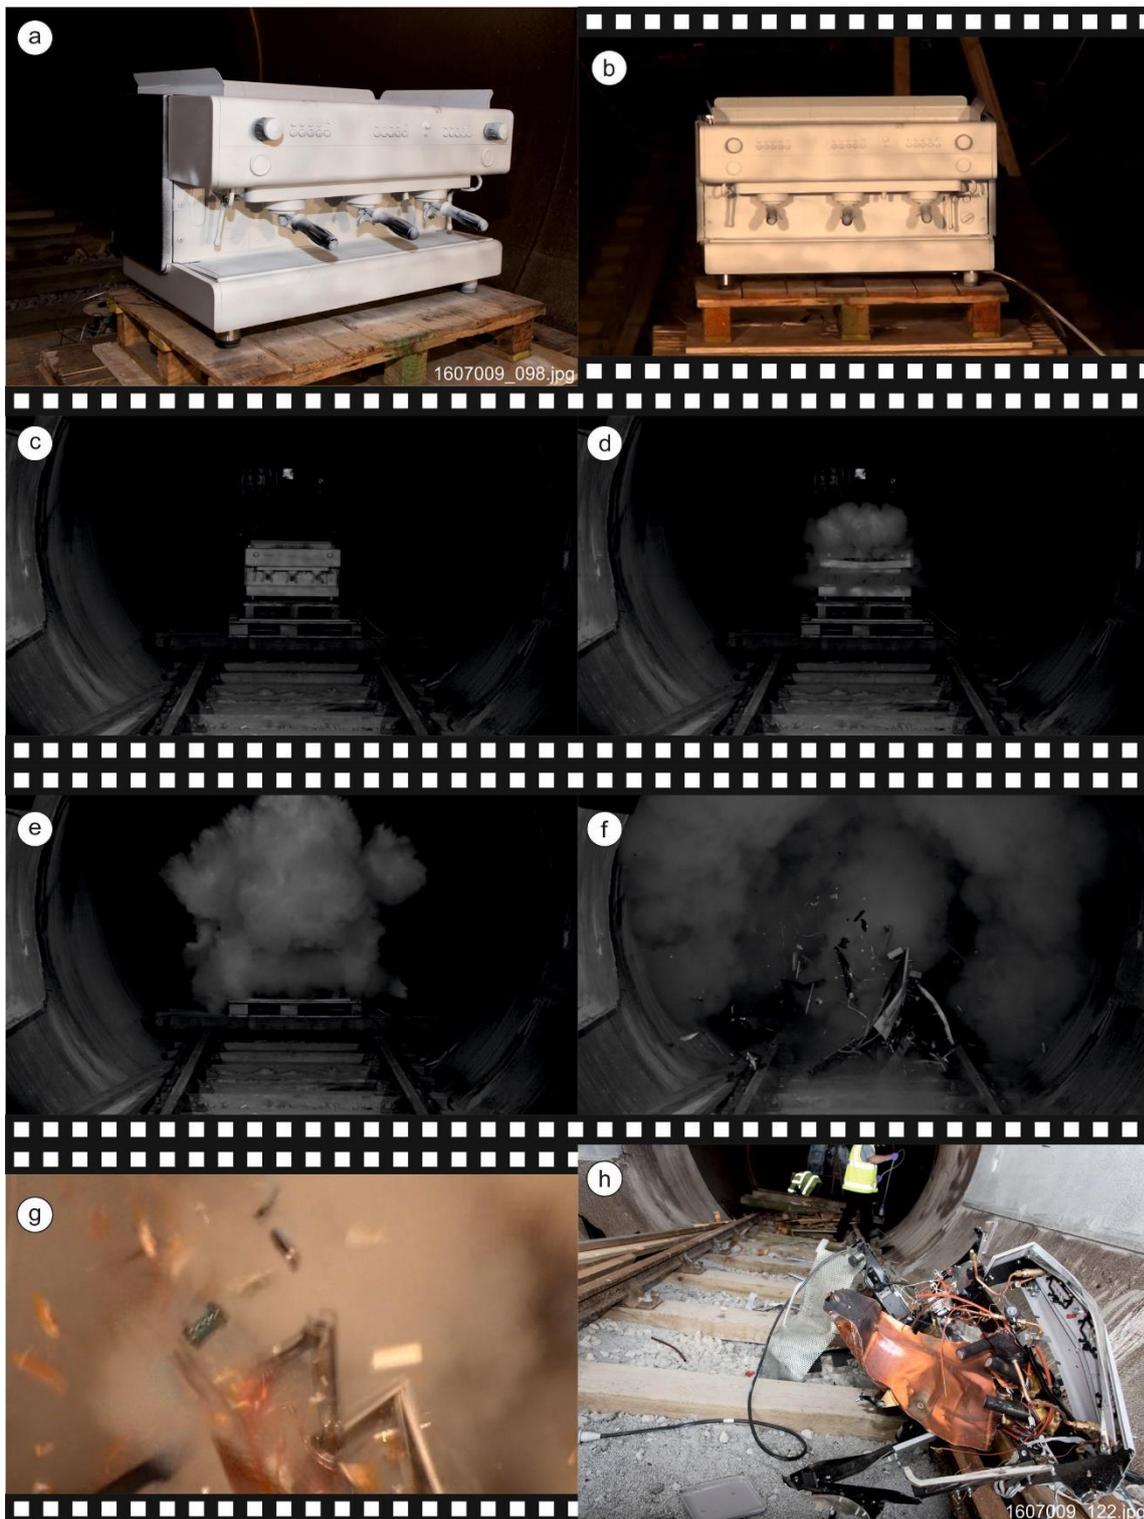
**Figure 30 Images from the test – manufacturer C (new)**

Insets b to g are sequences taken from the high-speed (black and white images) and high-definition video footage (colour images). There was no evidence of escaping steam prior to the failure of the boiler.

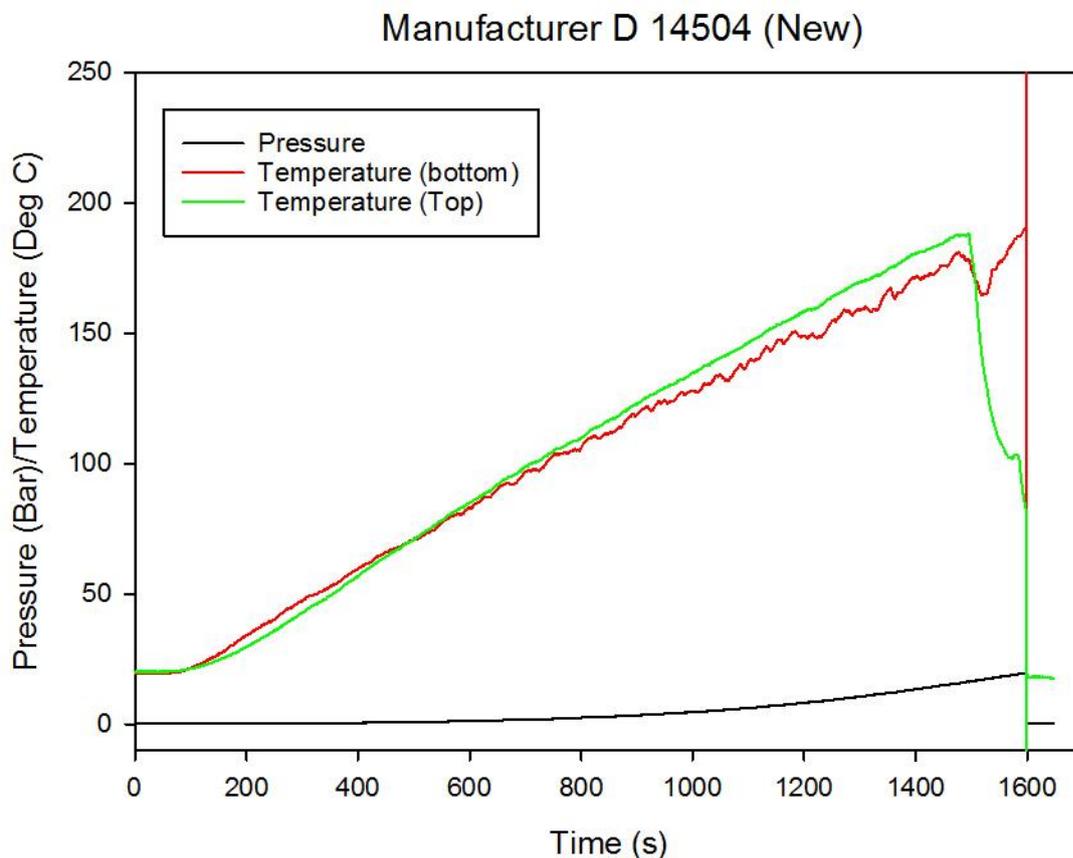
Testing proceeded without interruption. During the test, pressure and temperature increased steadily until, at around 13 bar pressure, a small volume of steam could be seen venting. This was possibly due to pressure relief within the brew head circuits. Catastrophic failure of the boiler occurred at 19.6 bar as shown in Figure 32.

**Figure 32 Pressure and Temperature Results – manufacturer D (new)**

Shortly before failure, reductions could be seen in both the top and bottom temperature readings (especially the top): the cause of these drops is unknown. However, on this machine the boiler had been supplied with a metal band secured approximately around the centre diameter. The thermocouples were mounted near to, or even beneath this

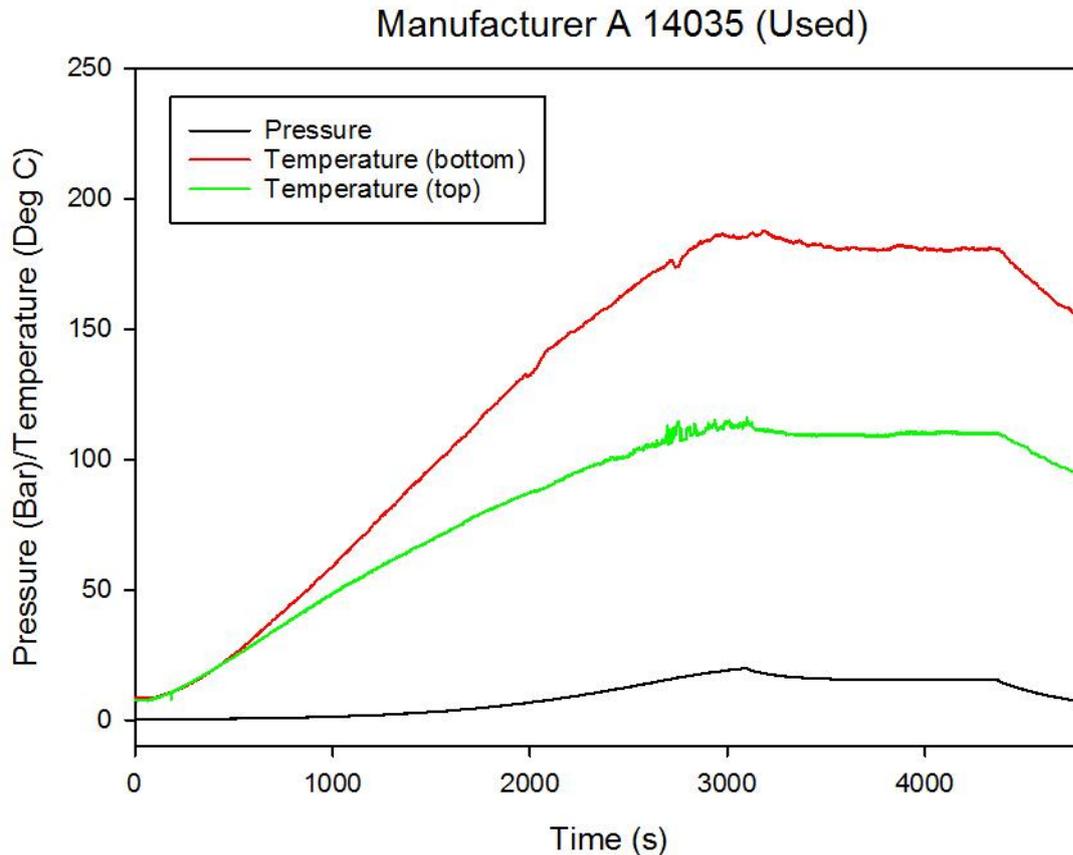
During testing the pressure and temperature increased steadily until a jet of steam was observed exiting the top left-hand side of the machine at 19.9 bar. The test was allowed to continue for some time after this event to observe whether the leakage could be overcome. Temperatures and pressure stabilised with no indication of increasing. After this occurred, the test was stopped. Figure 35 shows the results.

**Figure 35 Pressure and Temperature Results – manufacturer A –2nd hand (used)**

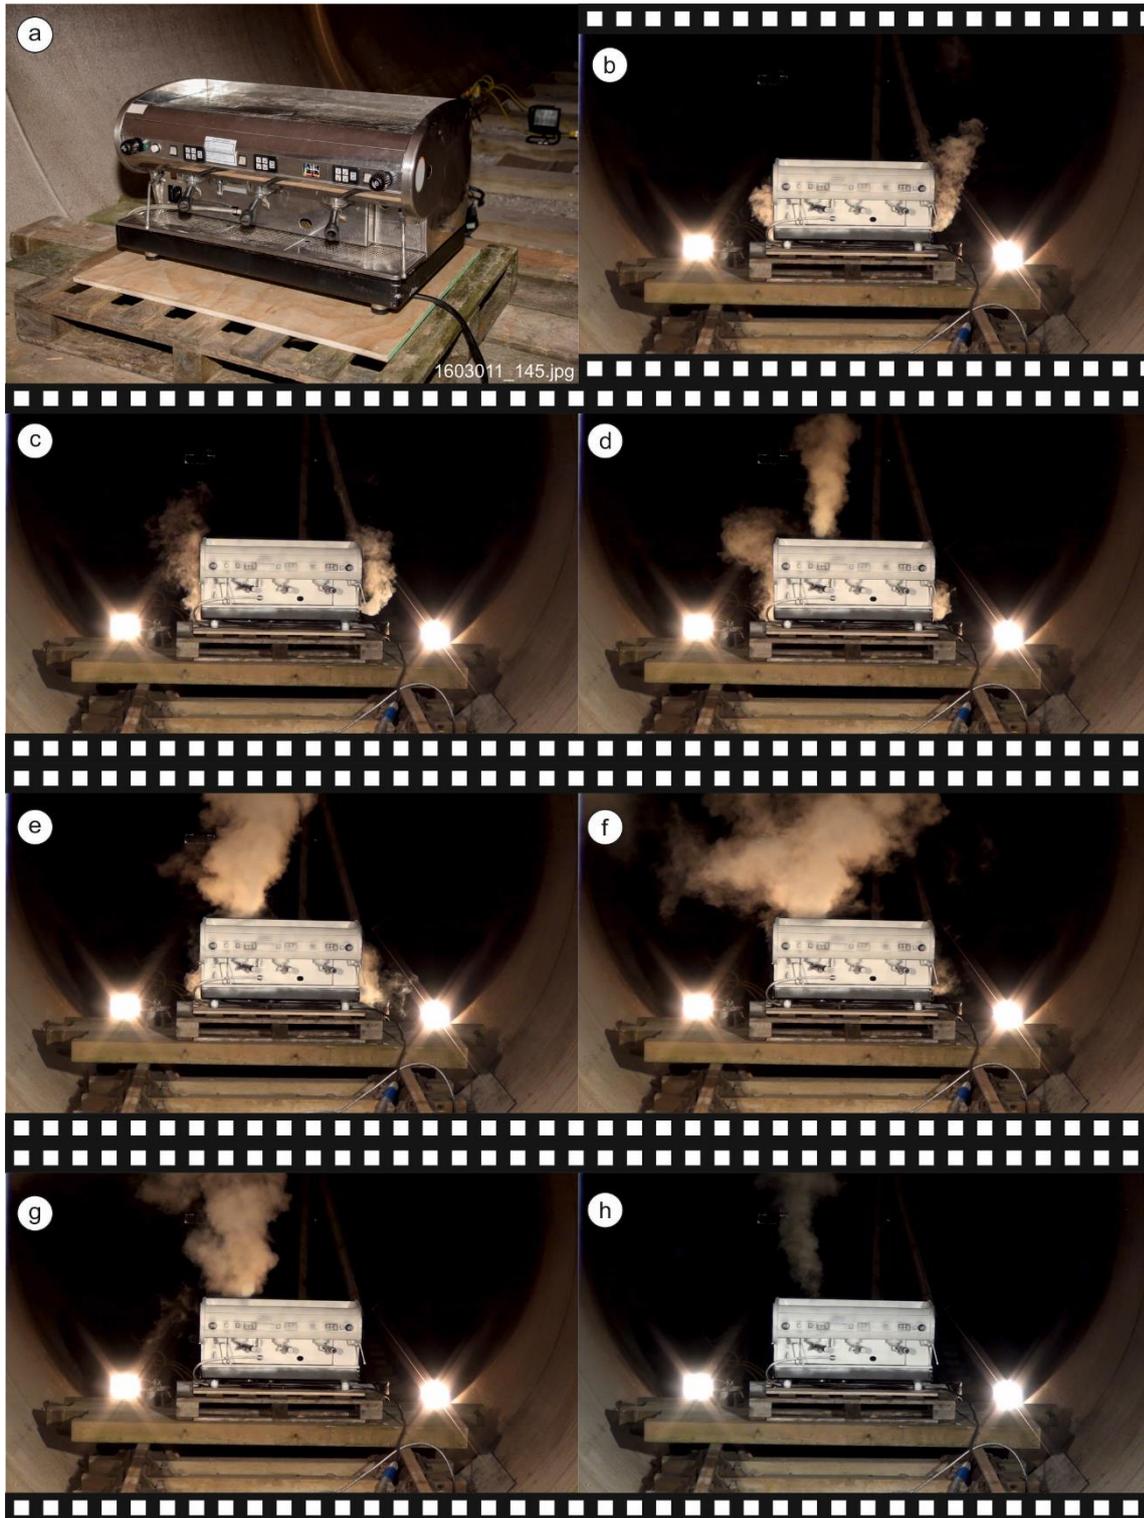
**Figure 36** Images from the test – manufacturer A (2nd hand)

As no catastrophic failure occurred, the machine did not look any different (externally) after the test, as can be seen from the sequences in Insets b to h taken from the high-definition video footage. Note the steam escaping from the top left-hand side (inset images d to h). During post-test examinations, a crack was observed to the boss of a port on the top left-hand side of the boiler.

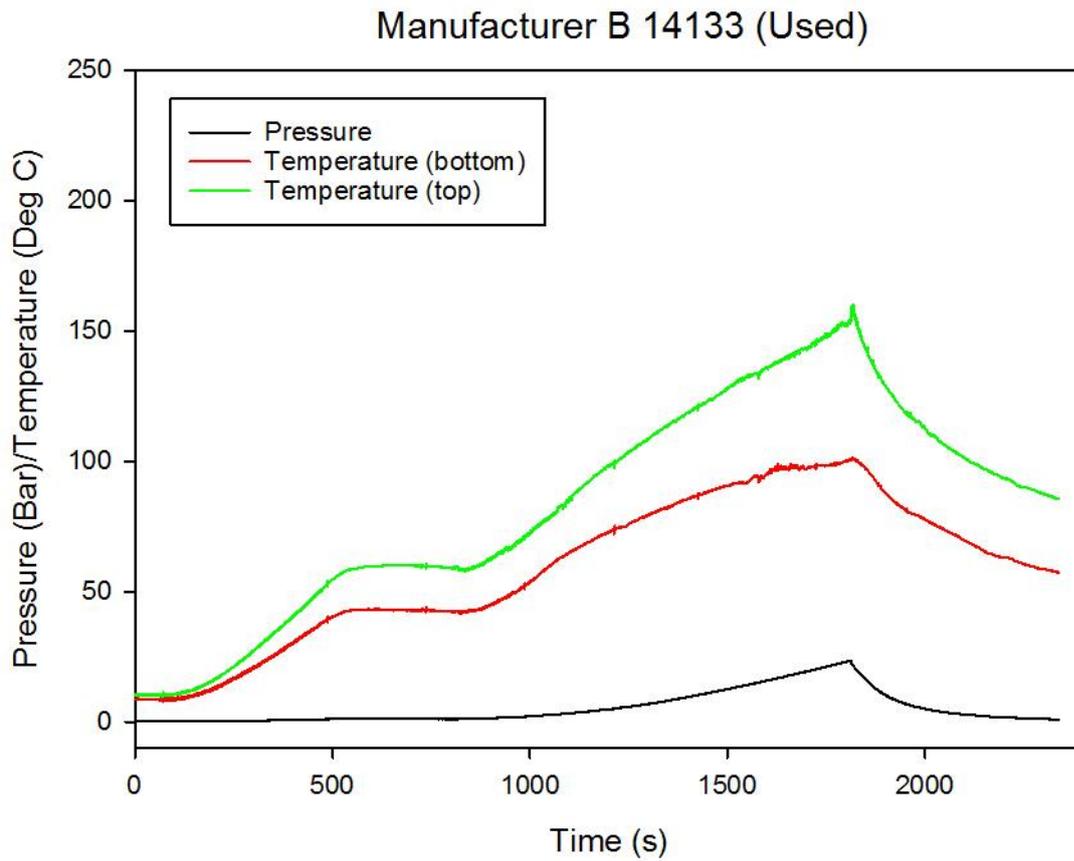
Testing was paused during the heating phase due to the failure of a generator set powering the lights for the video. This pause can be seen in Figure 40 where the three curves flatten-out after 500 seconds until about 800 seconds. Following the restart, pressure and temperature increased steadily until, at 23.6 bar, a sudden release of steam was observed escaping from the right-hand side of the machine. This failure was accompanied by a rapid loss of pressure, which did not show any indication of re-building, therefore the test was stopped.

**Figure 40 Pressure and Temperature Results – manufacturer B – 2<sup>nd</sup> hand (used)**

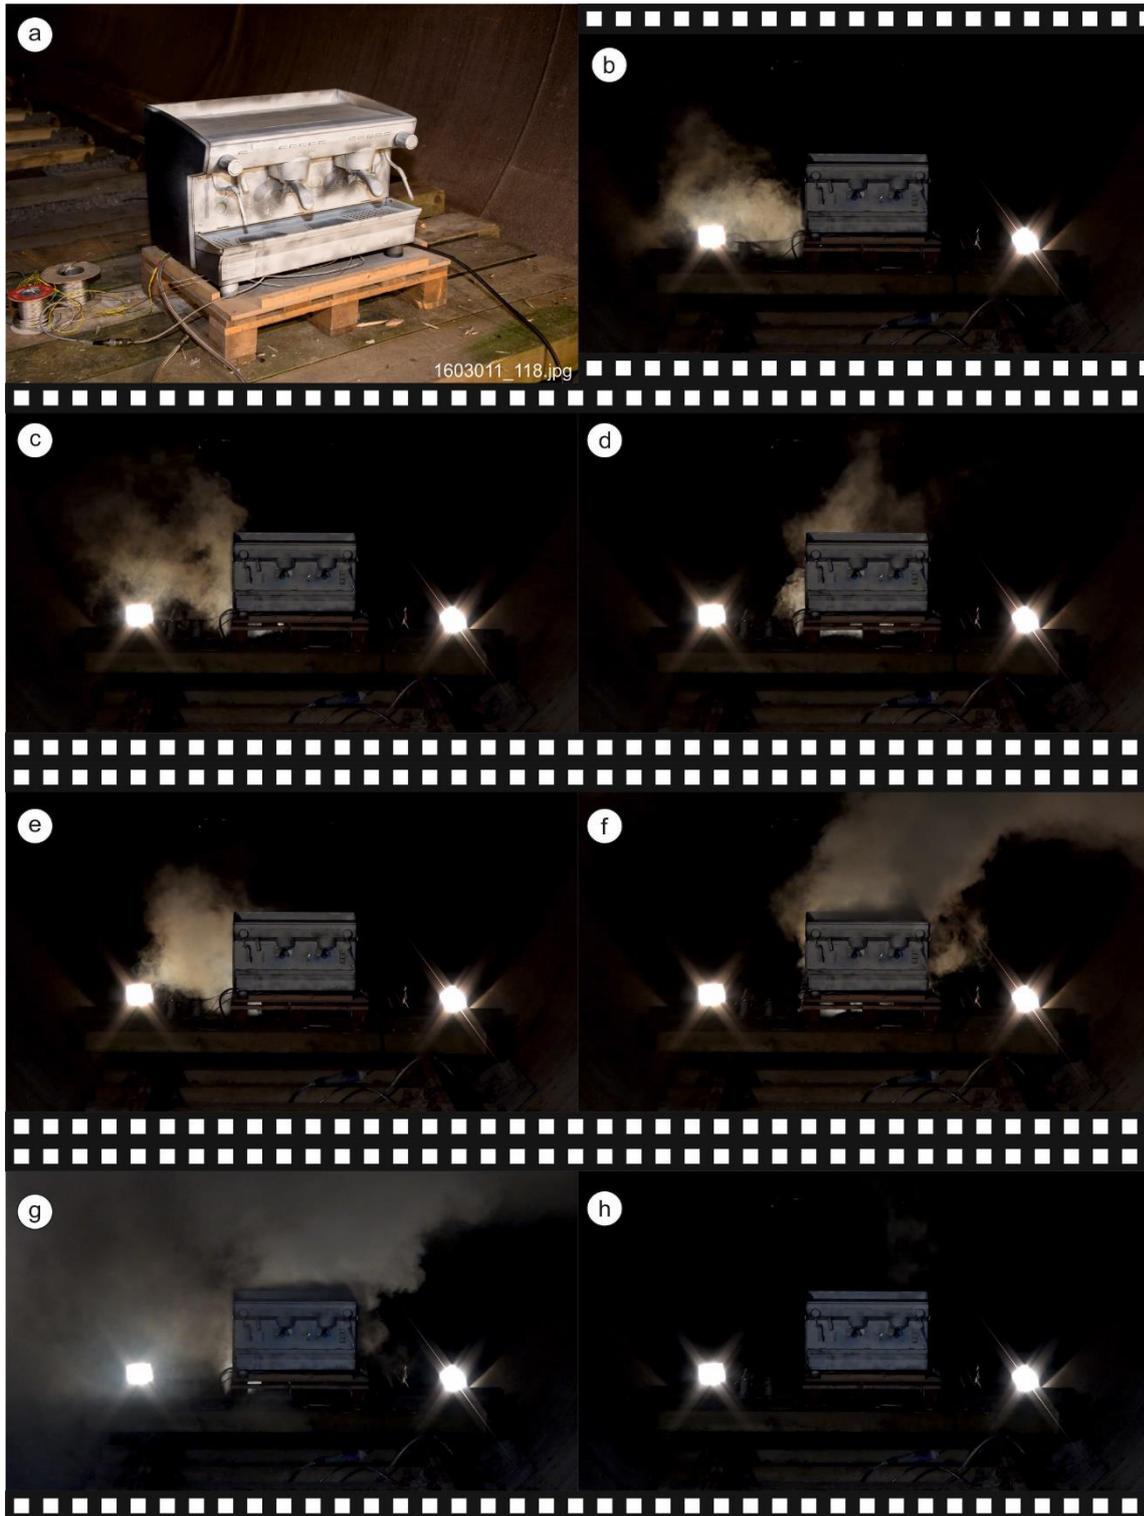
**Figure 41** Images from the test – manufacturer B (2nd hand)

As no failure occurred, the machine did not look any different (externally) after the test as can be seen from the sequences in Insets b to h taken from the high-definition video footage. Note the large volume of steam escaping from the top right-hand side (inset images f and g). During post-test examinations, a crack was observed in the boss of a port on the top right-hand side of the boiler.

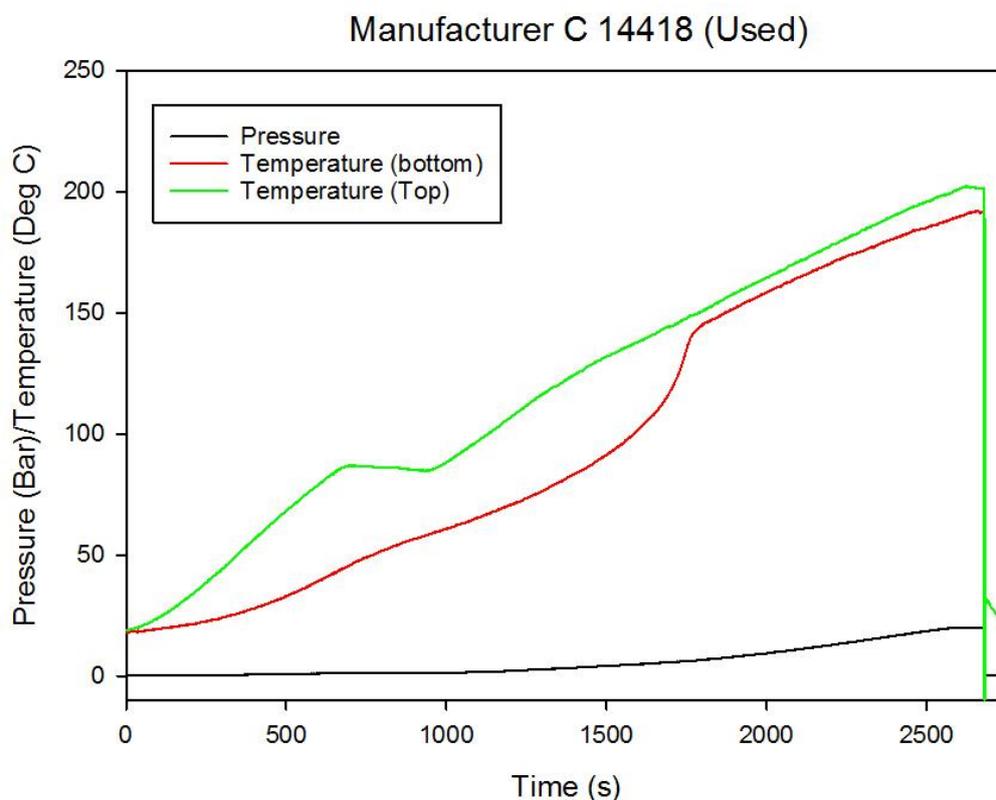
Testing proceeded with only one interruption, when heating was paused during the early phase of the test to allow access across the exclusion zone. This can be observed as a plateau on the top thermocouple trace in Figure 45, at around 600 seconds. During the test, pressure and temperature increased steadily until a small volume of steam could be seen venting at around 18 bar and again at 20 bar. This was in the region of the drip tray and may have been venting from the brew head circuits.

Temperature and pressure continued to rise steadily prior to a short plateau, which occurred shortly before catastrophic failure at 20.2 bar.

**Figure 45** Pressure and Temperature Results – manufacturer C – 2<sup>nd</sup> hand (used)

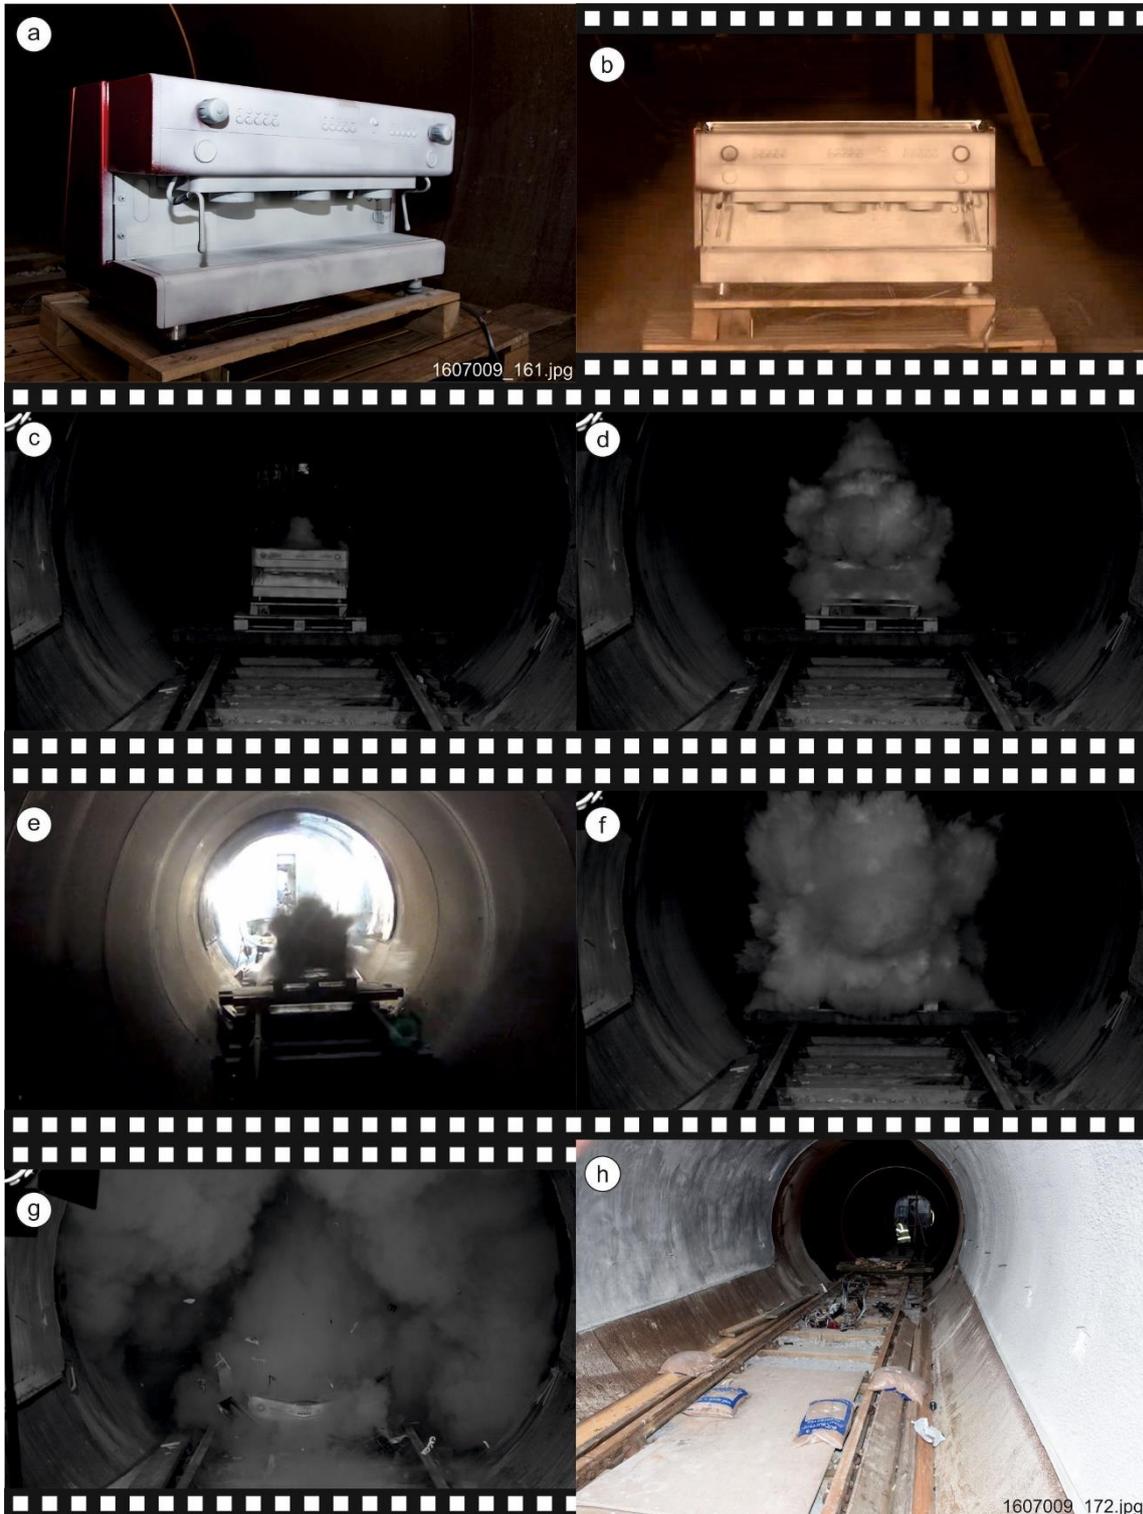
Figure 46 Images from the test – manufacturer C (2nd hand)

Insets b to g are sequences taken from the high-speed (black and white images) and high-definition video footage (colour images). Inset image e was recorded from behind the machine. This was the only second-hand machine to suffer catastrophic boiler failure during the overpressure testing.

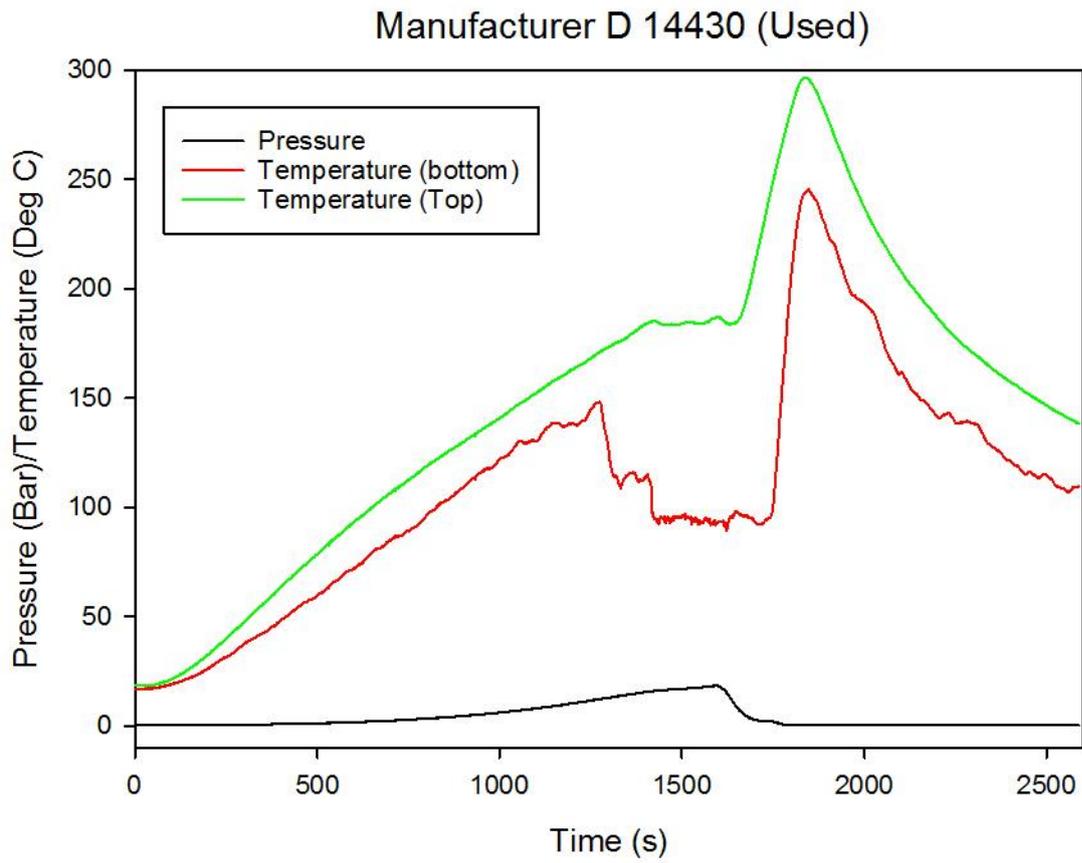
Testing proceeded without interruption. During the test, pressure and temperature increased steadily until a small volume of steam could be seen venting at a pressure of around 4 bar. Temperature and pressure continued to rise until steam and water could be observed venting from the machine from around 14 bar (14 bar was achieved at approximately 1340 seconds) as shown in Figure 48.

Venting of water and steam continued until steam was no longer being emitted and temperatures started to climb rapidly. The test was aborted at approximately 300 °C to prevent fire.

Plateauing of the temperature from the upper thermocouple, and reduction of the temperature on the lower thermocouple to approximately 95 °C was observed during the leak phase.

**Figure 48 Pressure and Temperature Results – manufacturer D – 2<sup>nd</sup> hand (used)**

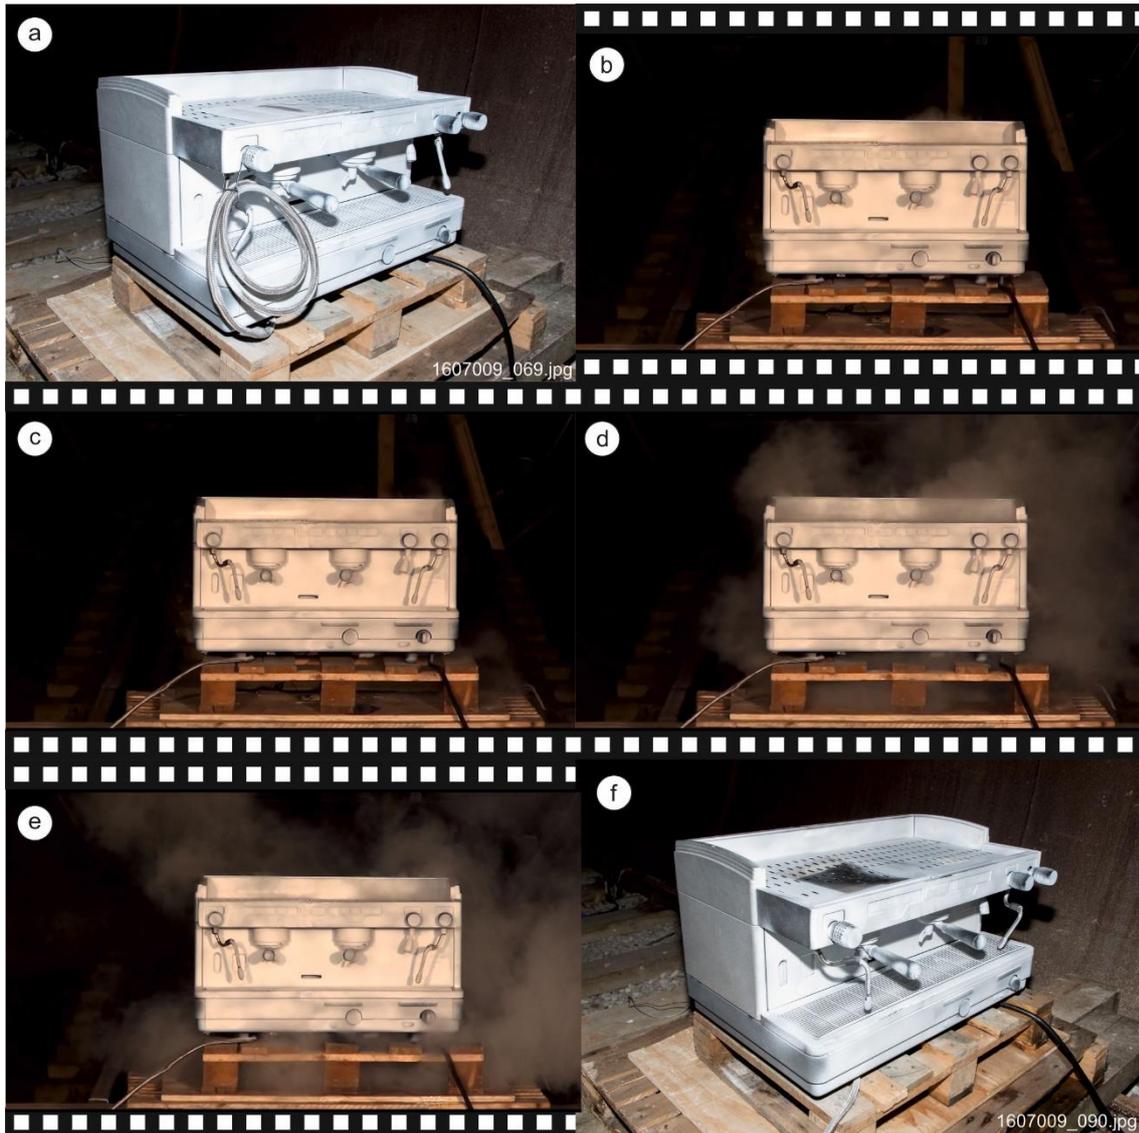
**Figure 49 Images from the test – manufacturer D (2nd hand)**

Insets b to e are sequences taken from the high-definition video footage. Note the general steam surrounding the machine in inset images d and e, and the areas of standing water on the pallet and base board. During post-test examination, a crack was observed in the drain port boss on the underside of the boiler. Staining of the boiler outer casing was also observed emanating from this failure location.

Sample 14430 had undergone a slow release during pressurisation, with dilation of the vessel having occurred. The slow-release leak was associated with the single drain port in the base of the vessel. Clear streak marks could be seen where the steam and fluids had emanated from the crack-like feature in the circumference of the port, Figure 50. In this instance the crack appeared to be within the port fitting itself, not the brazed joint. White powder residue on the port fitting and darker shadowing with green colouration on the

surface of the vessel adjacent to the fracture indicated that the leak may have been pre-existent to the testing.
