# **Risk control for small pressure vessels: café boilers, bench-top autoclaves, and model steam engines**

Prepared by researchers at the  
**Health and Safety Executive**

**RR1177 (2022)**  
**Research Report**

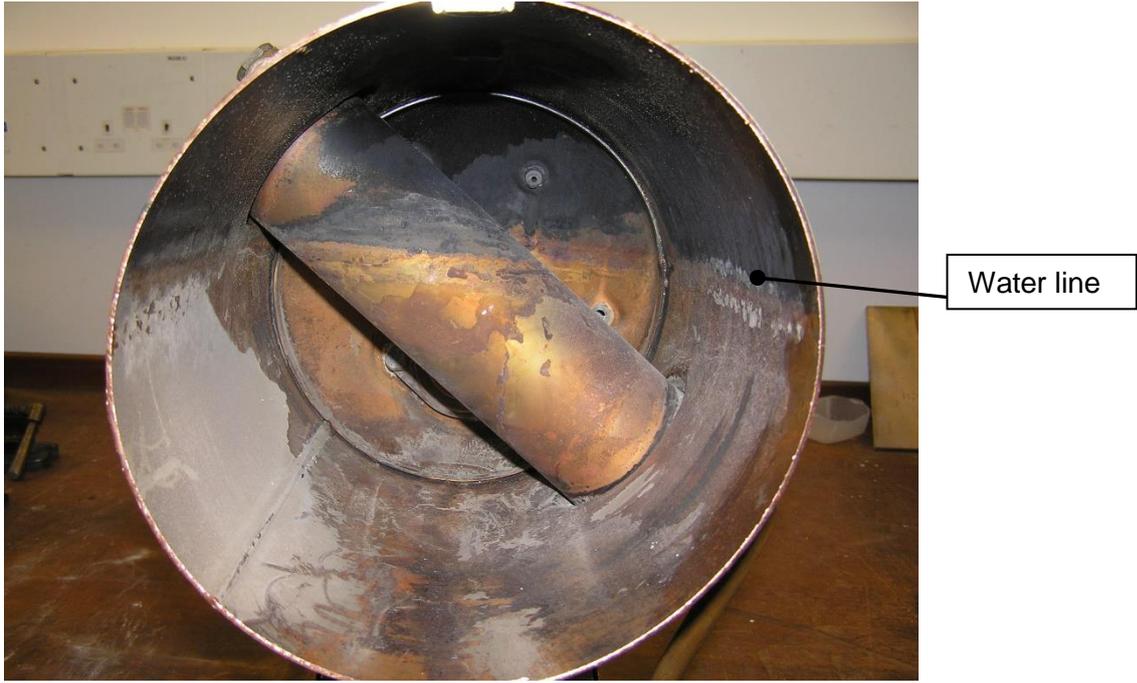
Figure 53 shows the interior of the boiler, with light lime-scale deposits BWL, and blackening of the copper wall AWL. The mean wall thickness of the vessel was 1.44 mm.

**Figure 53** Interior of boiler

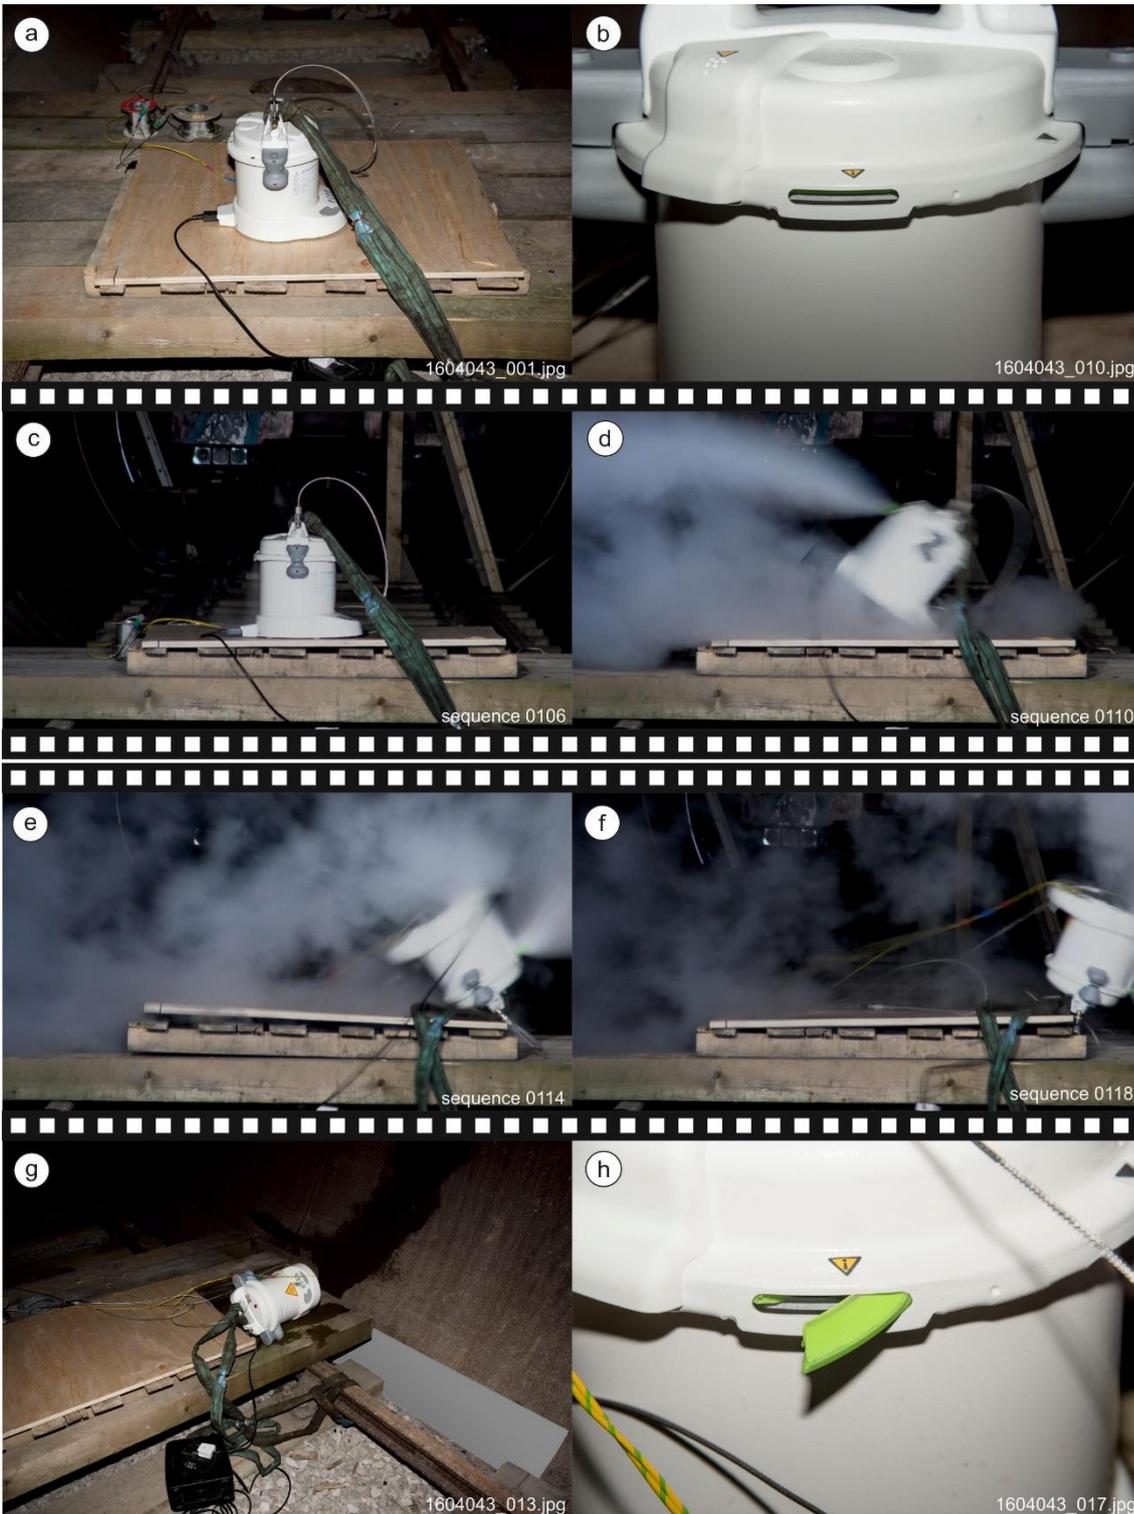
The autoclave was placed in the test facility, and for safety reasons, secured using a loose fitted fabric sling (inset a). The lid gasket extrusion slot is shown prior to the test in inset b. The sequence of frames from the video footage, shown in insets c, d, e, and f depict the failure. The lid gasket was extruded through the gasket extrusion slot, which allowed a jet of steam to escape rapidly, overturning the autoclave and displacing it from its original position. This distance was not measured, although the board upon which the autoclave was positioned at the start of the test measured approximately 1 m along the longest edge (left to right in the images). The final resting position is shown in inset g, note that the restraint remains slack. Note also the dark patch resulting from the ejected water and steam on the right-hand wall of the test facility.

Observation immediately after the test revealed that the lid gasket had split when it was extruded through the gasket extrusion slot (inset h).

**Figure 59 Overpressure testing of new autoclave 14427**

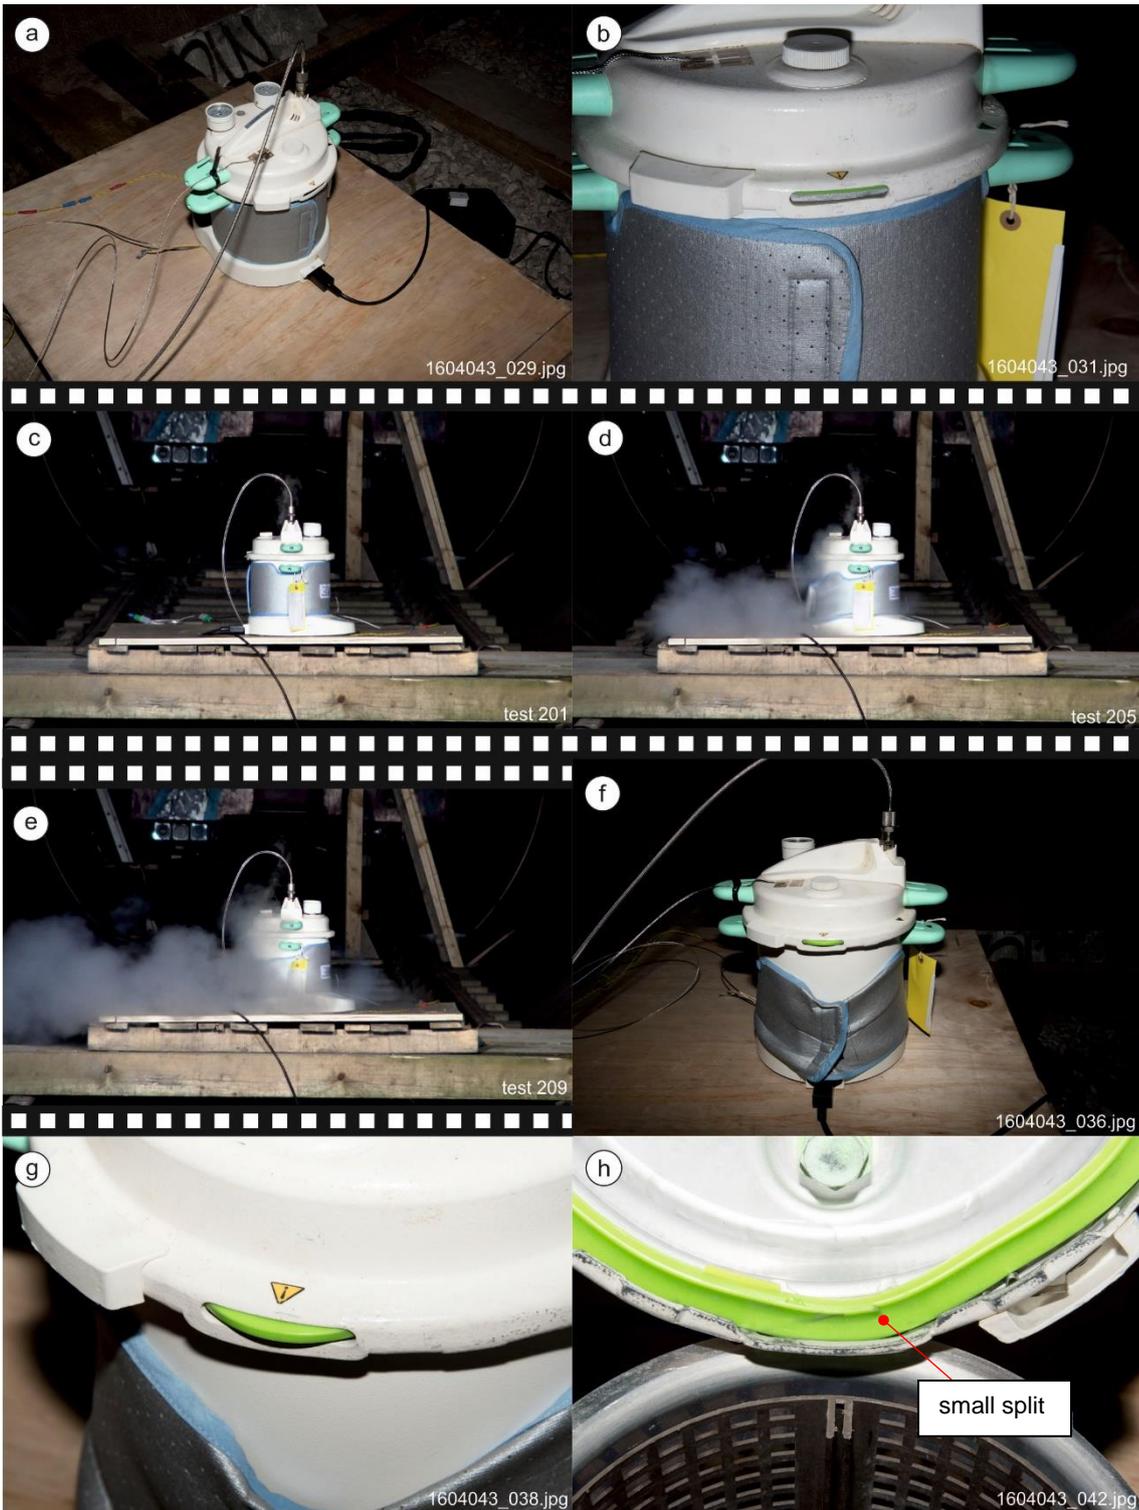
Images taken from the video of the test are shown in Figure 61. The second-hand autoclave was placed in the test facility (inset a) and was not secured, as the previous test had demonstrated that the risk of the lid section becoming detached was low. The gasket extrusion slot is shown, prior to the test, in inset b. The sequence of frames from the video footage, shown in insets c, d, and e, depict the failure as the lid gasket was displaced between the lid and base into the gasket extrusion slot. This allowed steam to escape beneath the seal in a controlled manner. Steam was observed exhausting in a downward direction, displacing the insulated jacket (inset f). The autoclave did not move during the release. Observation after the test revealed that the seal had remained largely intact but was partially ejected through the gasket extrusion slot (inset g). However, a small split was evident to one portion of the seal at the point at which it had displaced (inset h).

**Figure 61** Overpressure testing of 2nd hand autoclave 14426

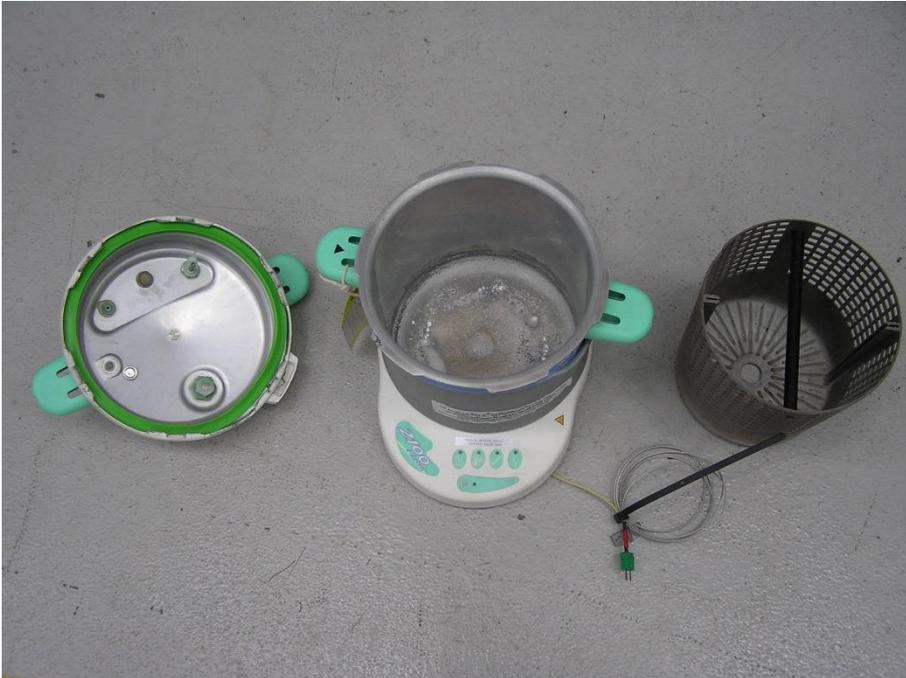
The chamber and lid for autoclave 14426 was identical in design and construction to the new one, although the mean wall thickness was slightly larger being 3.00 mm. Only with respect to the plastic base and basket design did it differ to any great extent. The machine

is shown (post-test) in Figure 64. The base of the chamber was coated with localised powder deposits and more general staining and deposit, Figure 65.

**Figure 64** Components of 2nd hand autoclave 14426 after overpressure testing (Image No. P1013005.jpg)

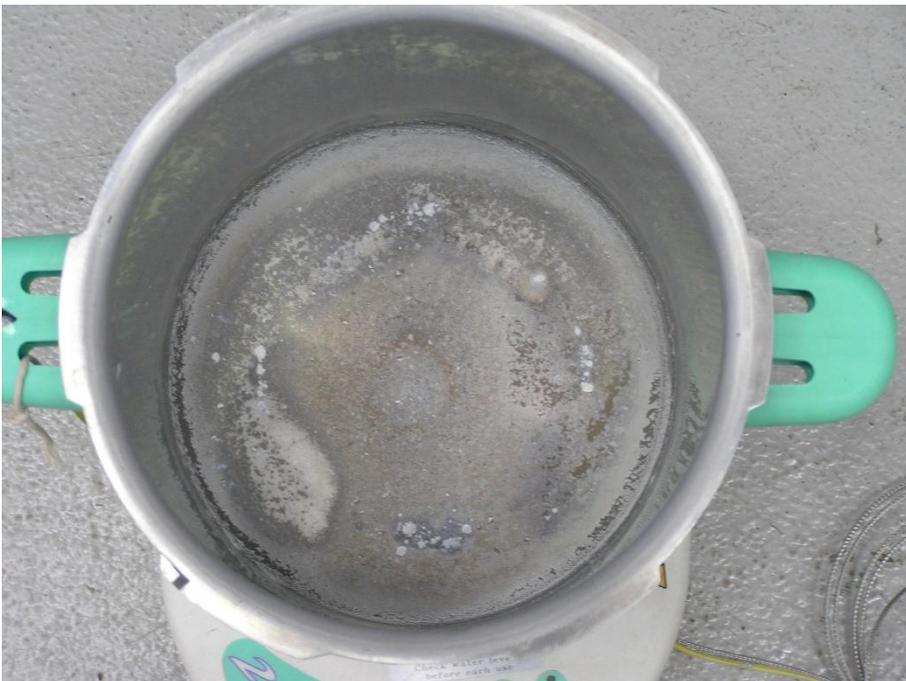
**Figure 65** Base of 2nd hand autoclave 14426 after overpressure testing (Image No. P1012998.jpg)

Using stereo microscope examination, small corrosion pitting features could be seen at the water line of the chamber and underneath the localised white powder caps on the base, Figure 66 and inset.
